# POKA-YOKE SHEET

**BEND PROBLEM**

**BENDING OF PULLEY MOUNTING AREA (RIB)  
OCCURES DURING PROCESSING IN CMB-DELPHI  
(CUSTOMER COMPLAINT).**

**SEC : MACHINE SHOP**

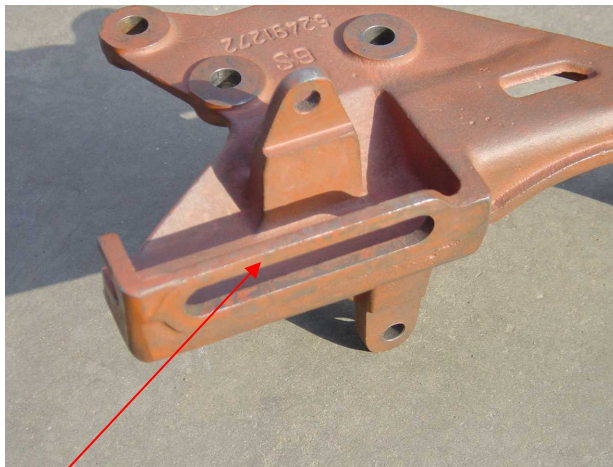
**BEFORE**

**No provision to detect the bending problem at pulley mounting area.**
