POKA-YOKE SHEET

PROBLEM: Dowel hole position with respect to marking position could not be maintained.

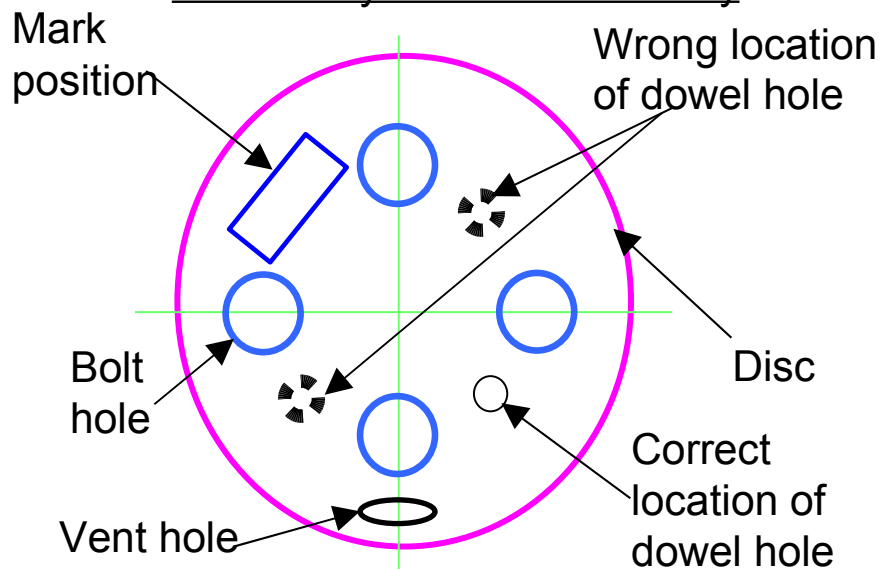
Before

Located by bolt hole form only

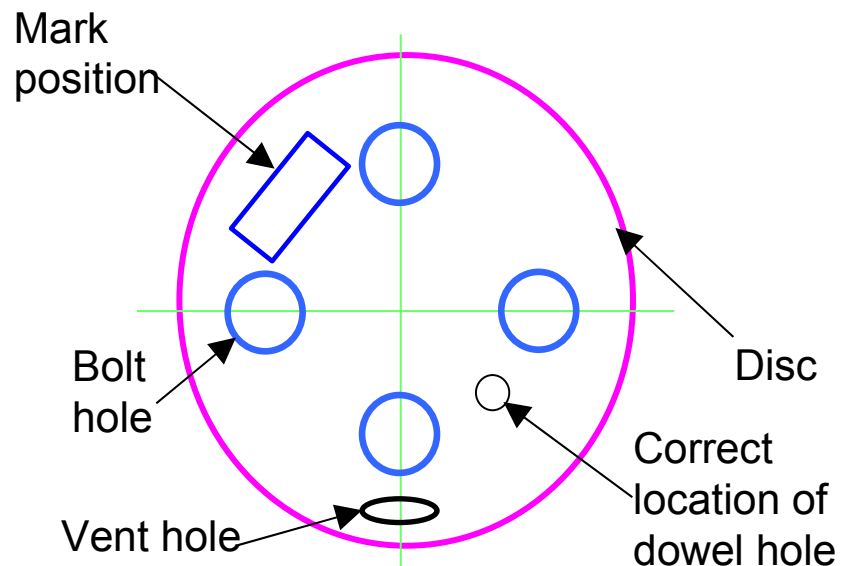
After

Located by both bolt hole and vent hole form

SOLUTION: The dowel hole piercing operation has been shifted from BHP operation which has BH location only, to pierce bore flange down operation in which the marking position is maintained automatically by the nature of tool configuration by both VH and BH location provided

KEY IMPROVEMENT: The operational scrap has been reduced to zero by this modification
