FAILURE OF BLEEDER VALVE

28.12.2005

G Blast Furnace

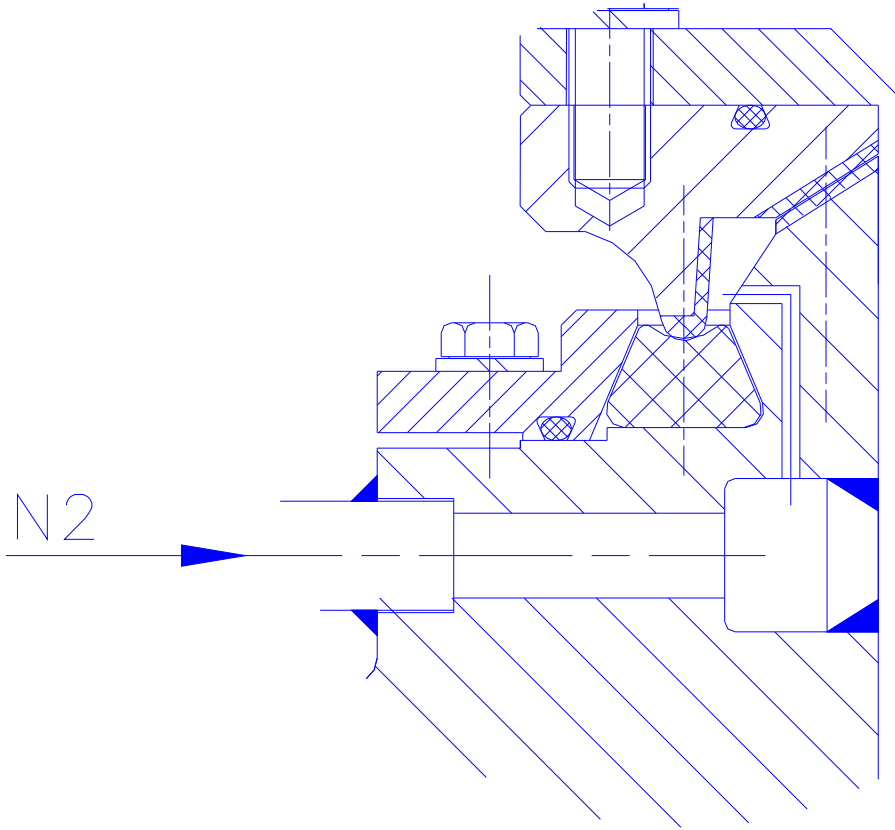
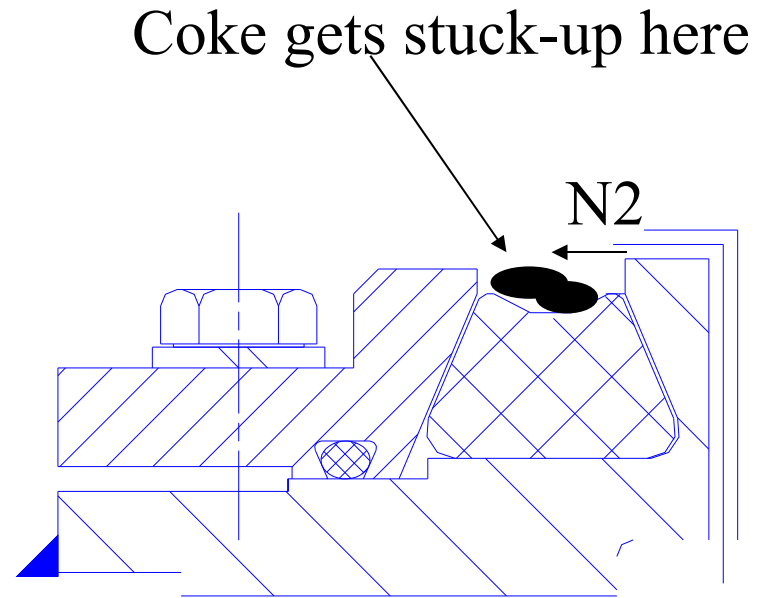
On 28th May, it was observed that the coke particles got pressed in sealing gasket, which was not sweep away by the flushing N₂, because the height of gasket pressing ring was 5mm more than the sealing gasket height. The higher elevation of gasket pressing ring was preventing coke particle to sweep away. Also it was observed that the available N₂ flushing arrangement was not covering the entire area of sealing gasket.

- When** 1st June 2005 in A Shift at 10.00 AM
- What** Gas leakage was observed from bleeder#2
- Where** From the bleeder valve#2
- Who** Mr. B.Kumar (Asst. Foreman) observed.
- Why** Bleeder valve opened just 10 minutes earlier.
- How** It was found that small coke particle was entrapped in sealing gasket & flushing N2 holes were jammed

To improve the N2 flushing arrangement, N2 flushing line should be made external type considering higher flow of N2.

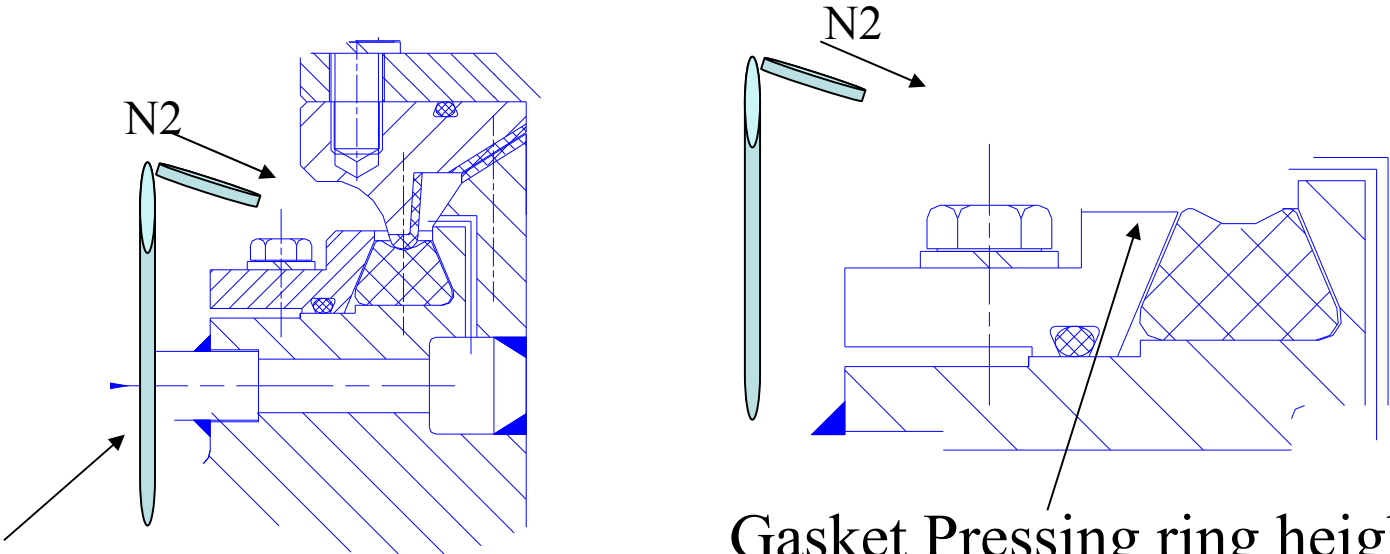
After

External N2 flushing provision

Gasket Pressing ring height Reduced by 6mm.

- **Gasket pressing ring height to be reduced by 6mm.**
- **External N2 flushing system to be introduced.**
