FAILURE ANALYSIS OF COIL CAR 8.1

Cold Rolling Mill

PROBLEM STATEMENT:

Frequent cycle stops of Coil Car 8.1 at Coil Packaging Line , CRM during the transfer of coils from entry to delivery side .

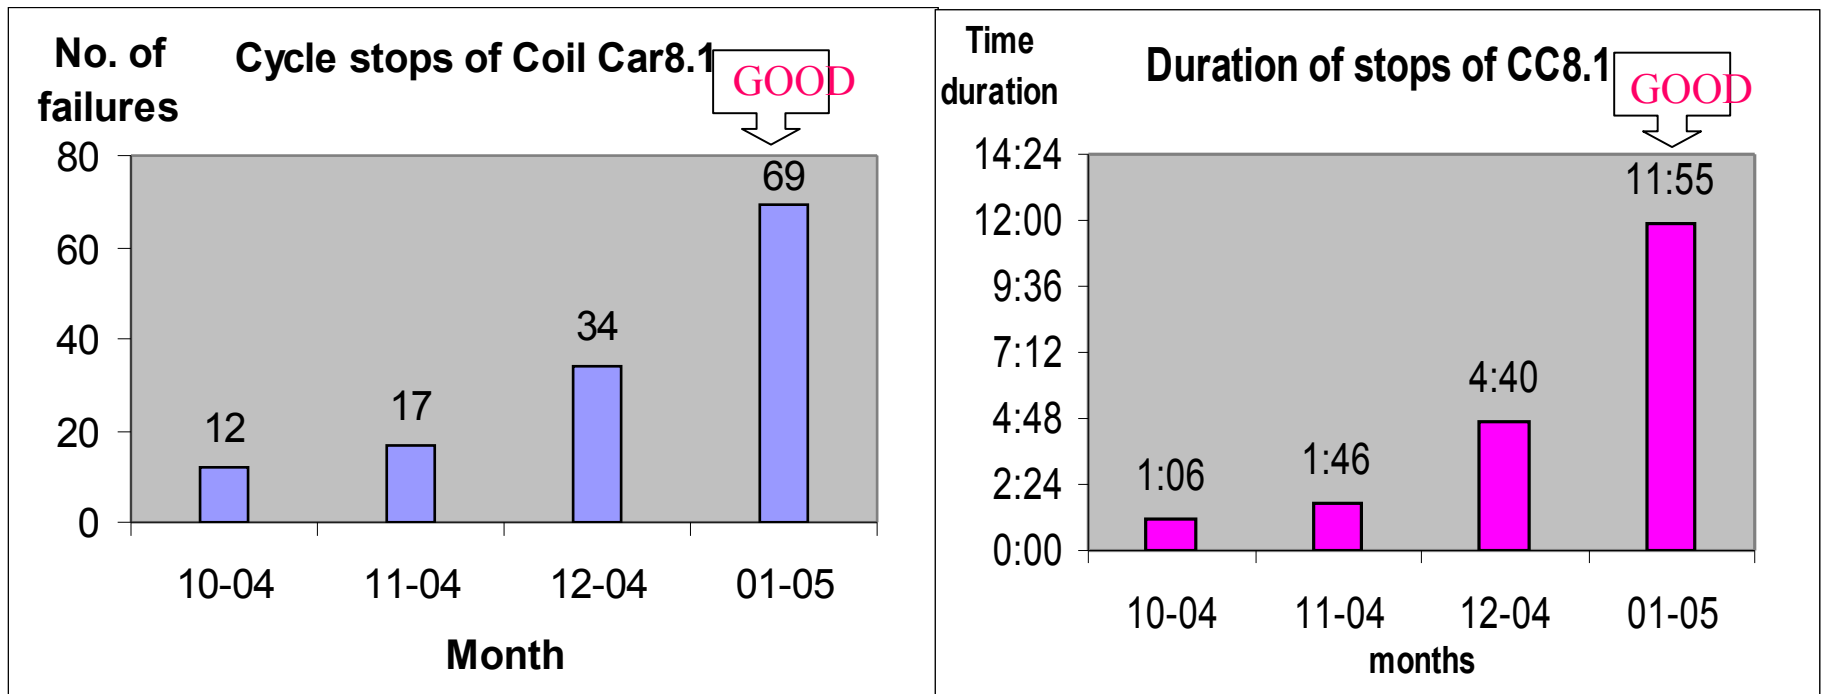
FAILURE HISTORY

PROBLEM TYPE --- CMNT .

This problem was effecting the production in CPL -

In the month of Jan'05 only , We had lost the opportunity to pack 180(approx) coils

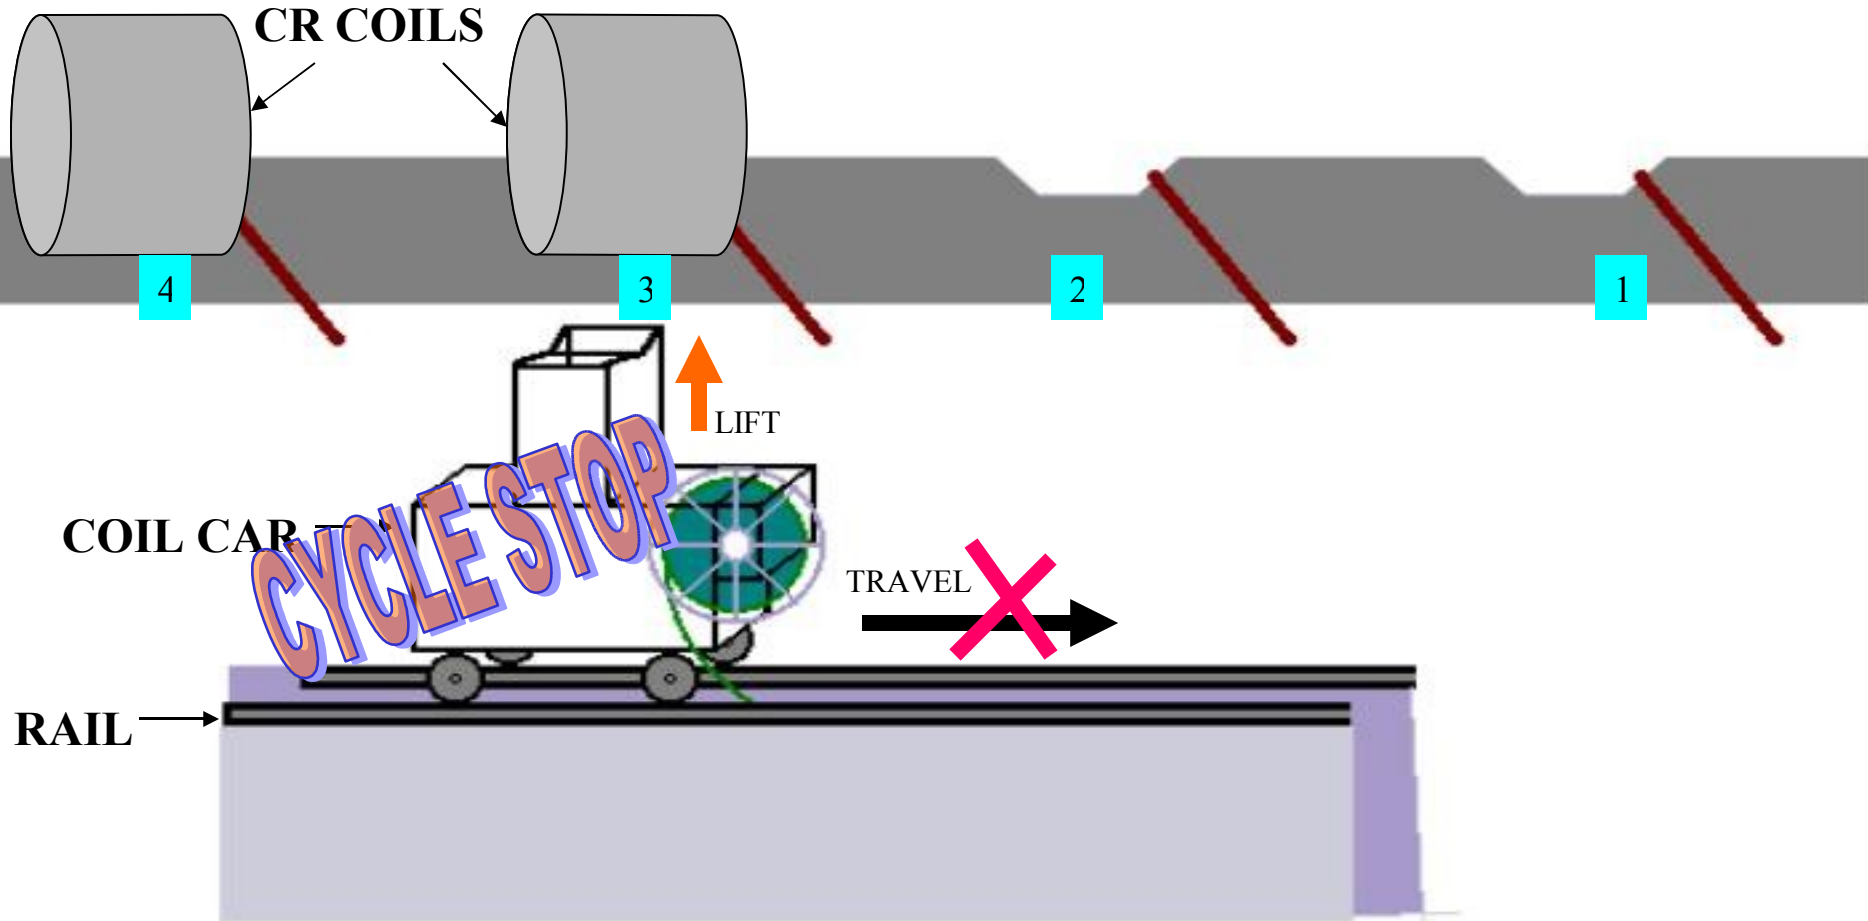
FUNCTION OF COIL CAR

Encoder monitor timeout comes only at Entry saddle#3 after lifting the coil and the coil weight >12T.

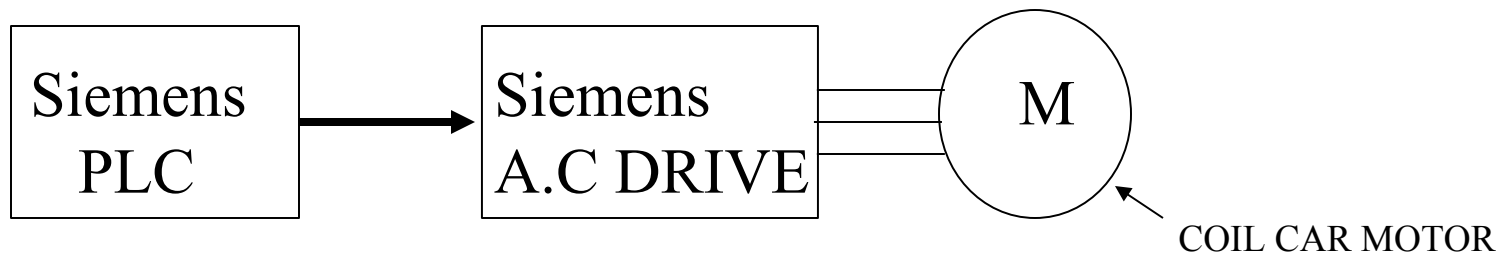
**COIL CAR NOT ABLE TO TRAVEL FORWARD
AFTER GETTING THE REFERENCE**

(It was observed that with a slight manual push , the car used to travel)

**DRIVE UNABLE TO PRODUCE THE
STARTING TORQUE**

PLAN	DO	CHECK	ACT
Tune the drive parameters to increase the starting torque	Increased the current limit of the drive and varied the proportional & integral constants	cycle stops are still coming	Revert to normal drive settings
Check various monitoring parameters of the drive	Monitored all the Current and Speed parameters of the Drive	Observed that sometimes the drive reference was very less	Check the drive reference coming from PLC.
Check the drive reference generating program.	studied the refernce generation program in PLC	Found some times drive reference is 1% of the full reference. This much reference is not able to drive the coil car at saddle#3 due to a small curvature on the Rail. (This reference is a close loop function of distance travelled by the car)	As it is very tidious job to replace the Rails, we planned to increase the reference during starting of the drive

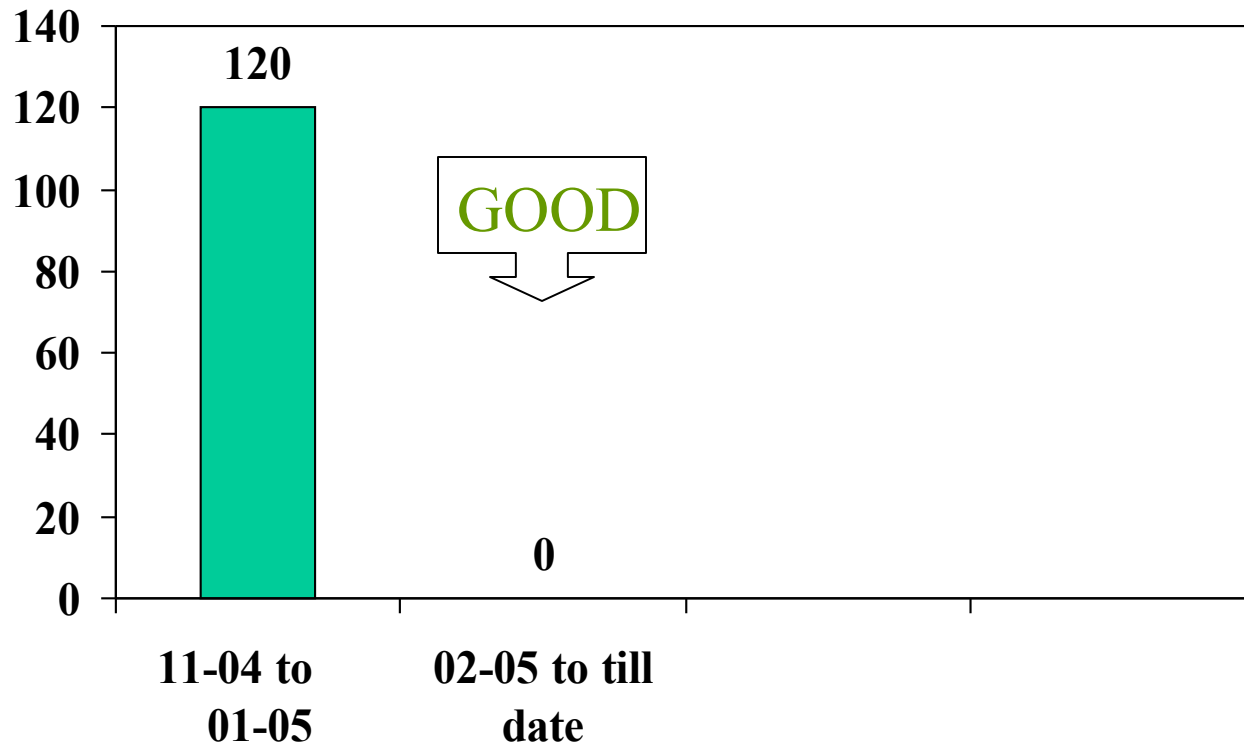
CYCLE STOPS OF CC8.1 AT SADDLE#3

BEFORE IMPL.

AFTER IMPL.
