Failure of Vessel #2 non drive end
Bearing at LD#2

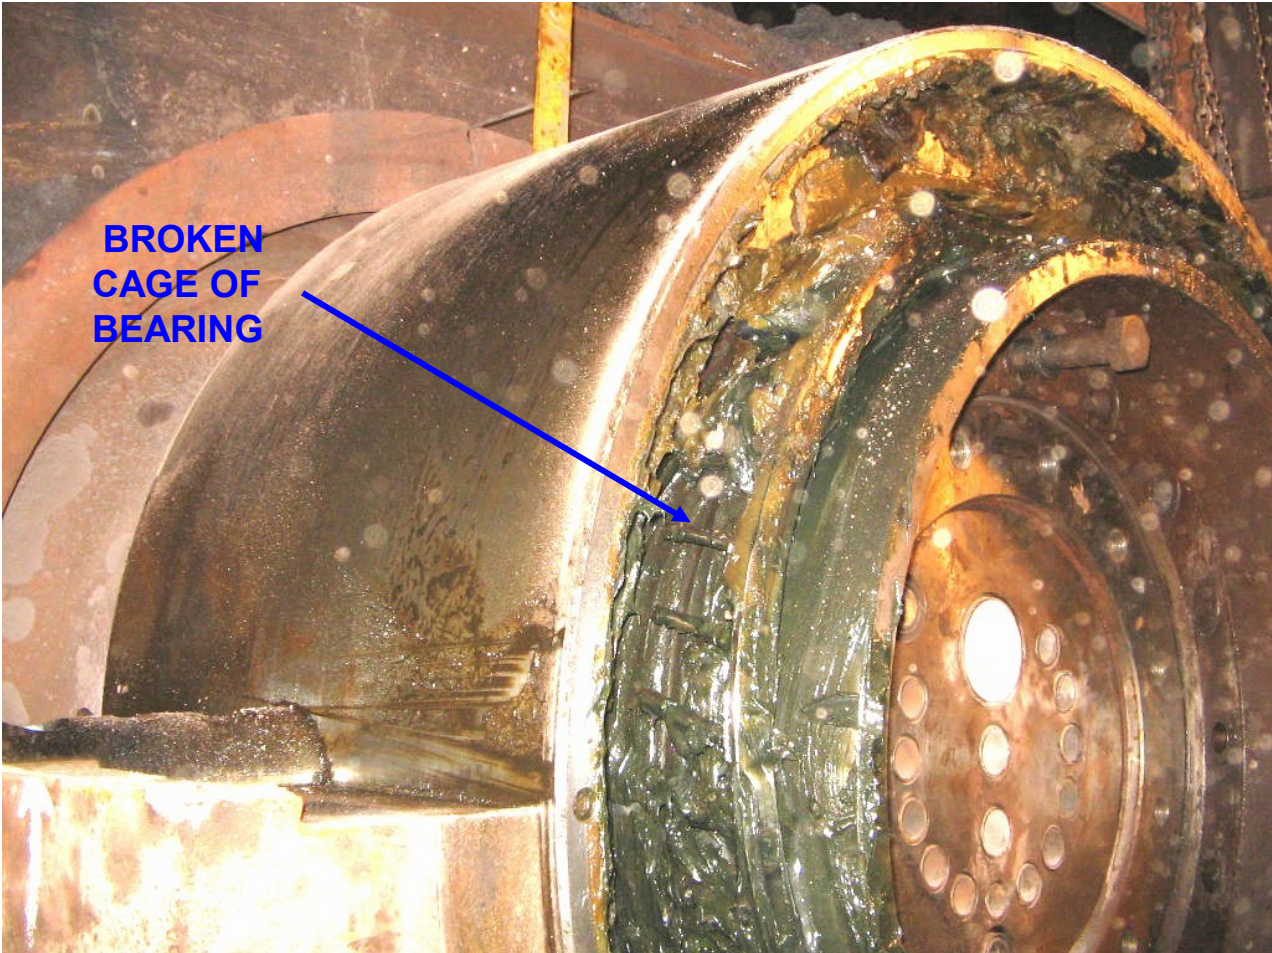
DAMAGED BEARING

- THE LOWER HALVES OF VESSEL SIDE END COVER AND LABYRINTH RING WERE FOUND DISTORTED AND DAMAGED
- THE SEAL OF THE VESSEL SIDE WAS FOUND IN BADLY DAMAGED CONDITION
- MANY ROLLERS OF THE INNER ROW WERE FOUND BROKEN
- ALL PINS OF INNER CAGE WERE FOUND BROKEN AND ALL THE ROLLERS HAD COME OUT
- MOST OF THE ROLLERS OF THE OUTER ROW WERE FOUND IN REASONABLY GOOD CONDITION BUT FOR NORMAL WEAR AND TEAR
- ABOUT 80% PINS OF OUTER CAGE WERE FOUND BROKEN
- THE TRUNNION PIN WAS BADLY DAMAGED
- SIDE COLLAR OF THE INNER RACE WAS FOUND DAMAGED ON THE INNER SIDE. THIS DAMAGE WAS FOUND TO BE MORE IN THE LOWER MOST (IN VERTICAL POSITION OF THE VESSEL) PORTION OF INNER RACE

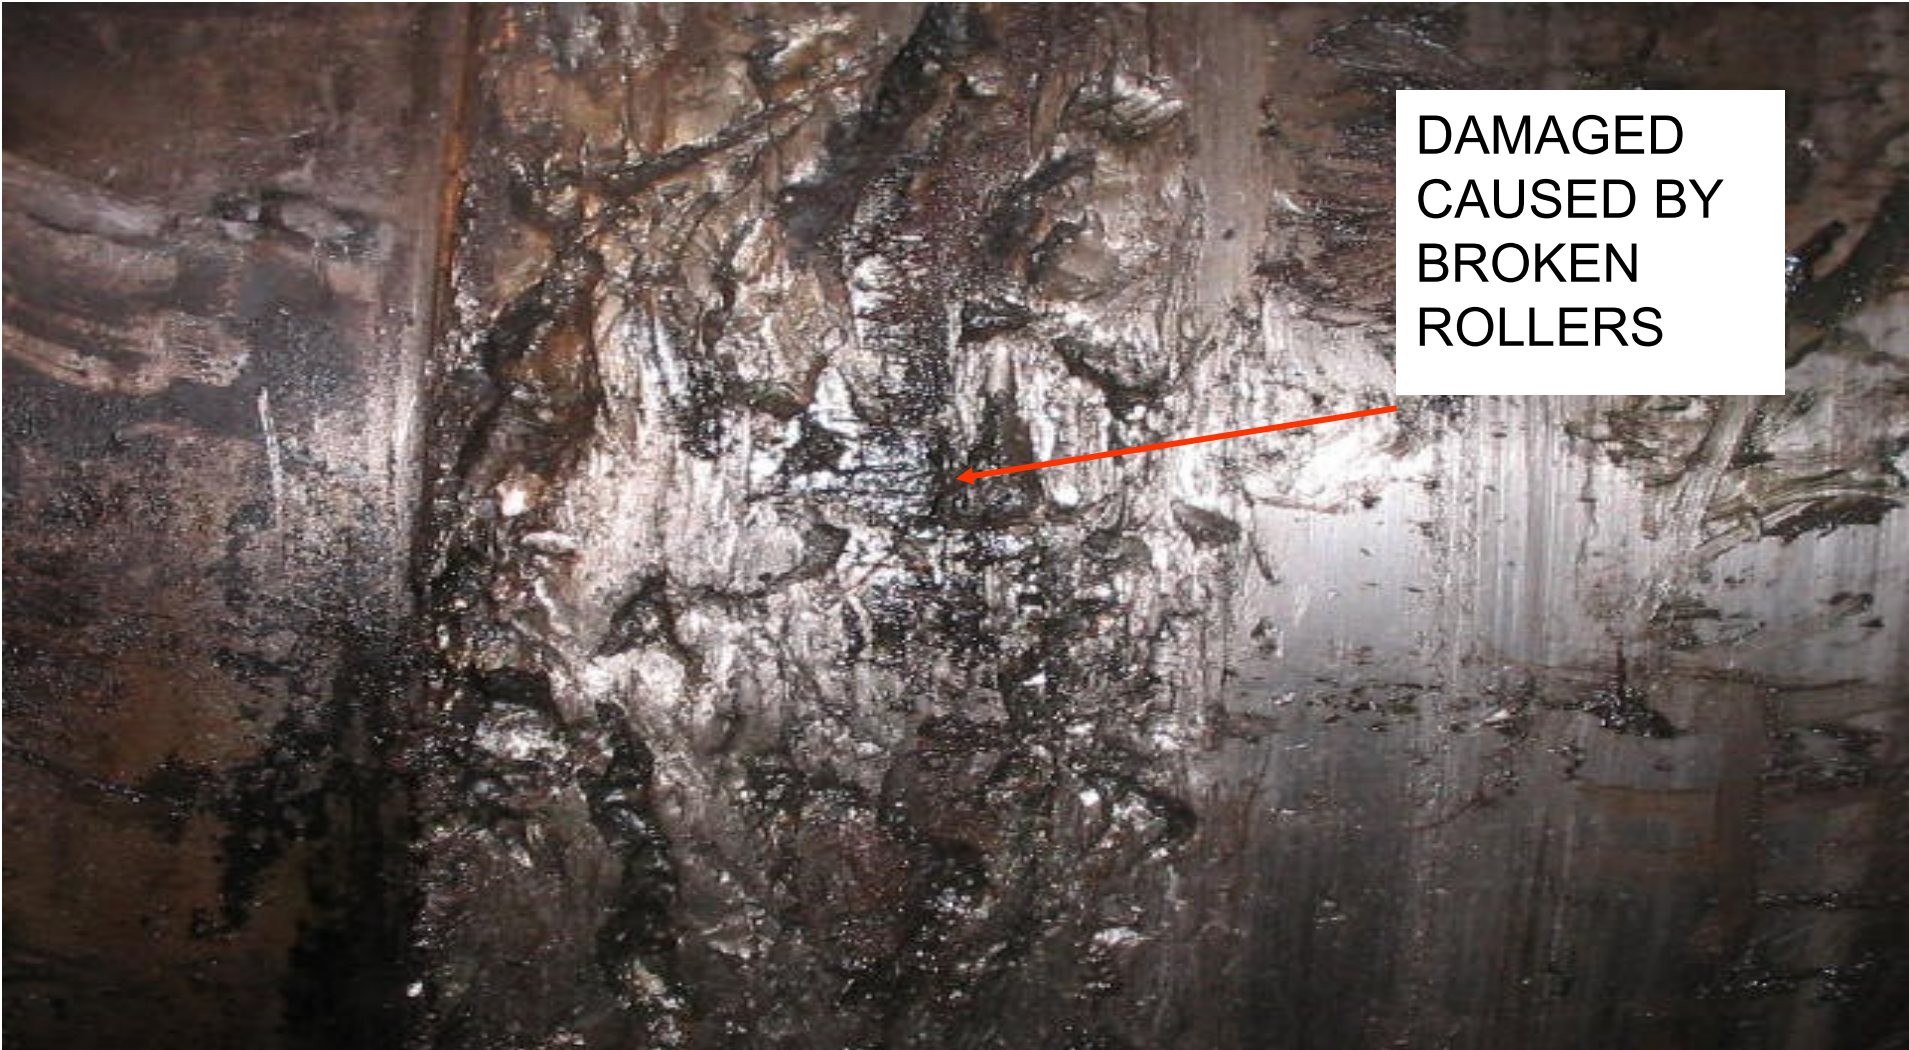
DAMAGED PIN OF VESSEL

DAMAGED
CAUSED BY
BROKEN
ROLLERS

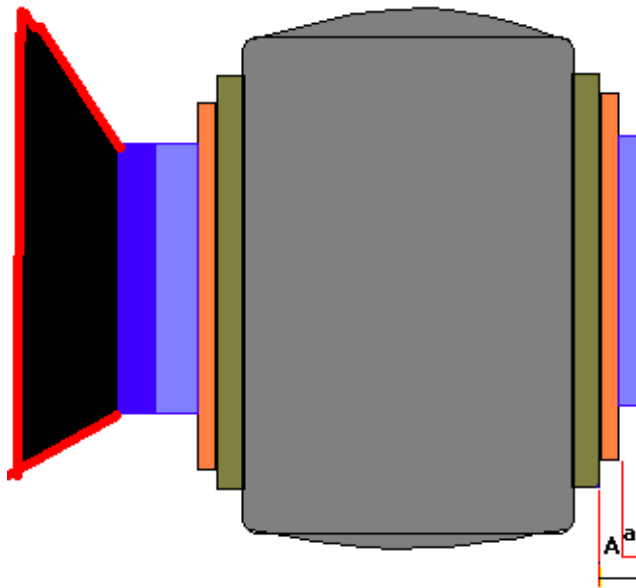
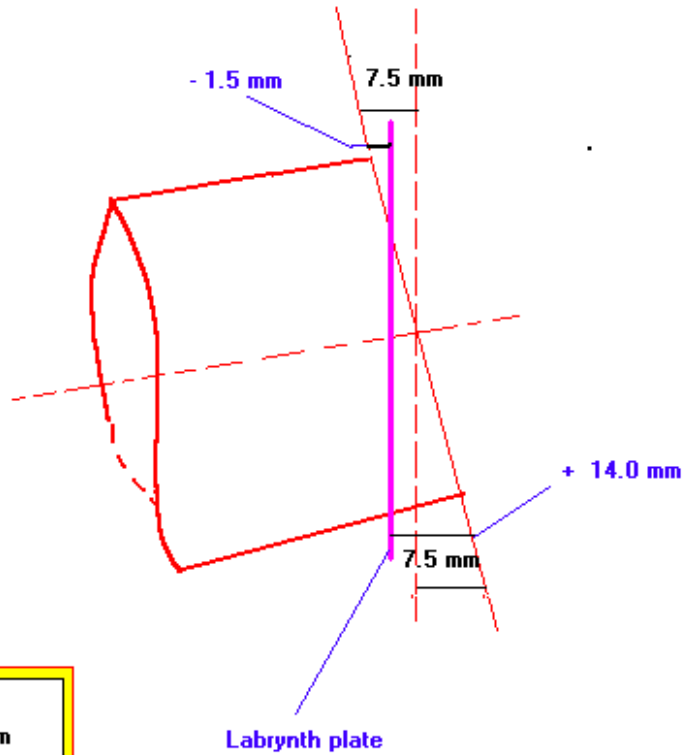
- THE TRUNION PIN HAS A DEFLECTION OF 1.2 DEGREES (18 MM OVER 850 MM)
- THE BEARING CENTRE HAD SHIFTED BY 70 MM TOWARDS CONVERTER INSIDE THE BEARING HOUSING (MAXIMUM SHIFT ALLOWED IS AROUND 60 MM).

Length of projected grease nipple is 32 mm

'a' at top - 1.5 mm
'a' at bottom + 14.0 mm
'A' at top + 23.5 mm
'A' at bottom + 39.0 mm

ROOT CAUSE	REMEDIAL ACTION
AXIAL SHIFTING OF PIN BY 70 MM AGAINST ALLOWABLE LIMIT OF 60 MM	BEARING CHANGED AND PLUMMER BLOCK REPOSITIONED TO CREATE SPACE FOR MOVEMENT EITHER SIDE
ANGULAR MISALIGNMENT OF PIN WITH RESPECT TO BEARING HOUSING BY 1.2 DEG	THE TRUNION AND PIN OF ALL THE VESSELS WILL BE REPLACED . THE PIN AND BEARING SIZES WILL BE INCREASED FROM 800 MM TO 850 MM
