FALIURE ANALYSIS OF EXCITER GEARBOX AT SINTER PLANT # 1

EQUIPMENT NO	:	2080 (HOT FEEDER)
COMPONENT WHICH FAILED	:	EXCITER GEARBOX
FAILURE DATE	:	10/11/2005
TIME	:	6:00 PM TO 11:35 PM
TOTAL DOWN PERIOD	:	5.5 HOURS
LOSS DUE TO DOWN TIME IN RS:		70000 X 5.5 = 385000 = 3.85 Lac.

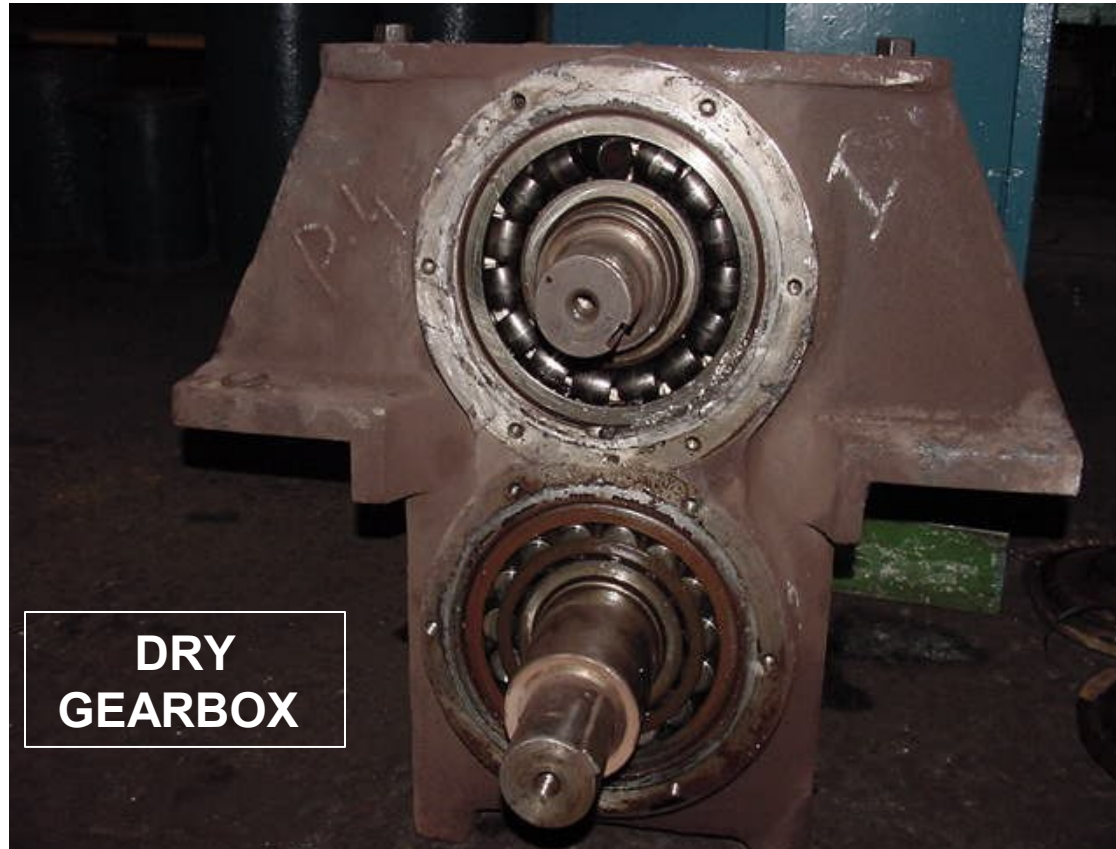
OBSERVATION NO : 1

Damaged bearing shows sign of oil starvation.

- ✓ Excess oil from the end cover goes back into the gearbox through the drain port which lubricates bearing.
- ✓ Felt used for sealing worn out due to excess heat and its ageing.
- ✓ Damaged felt choked the oil drain port.
- ✓ Due to blockage of drain port oil does not go back to gearbox and oil level starts reducing.
- ✓ This leads to oil starvation of bearing and bearing fails.

- ✓ **For sealing purpose felts should be replaced by rolled yarn consisting of PTFE which can absorb maximum temperature.**
- ✓ **Correct oil level of the gearbox to be maintained.**
- ✓ **A Time based maintenance schedule to be prepared for exciter gearbox changing to overcome ageing effect.**

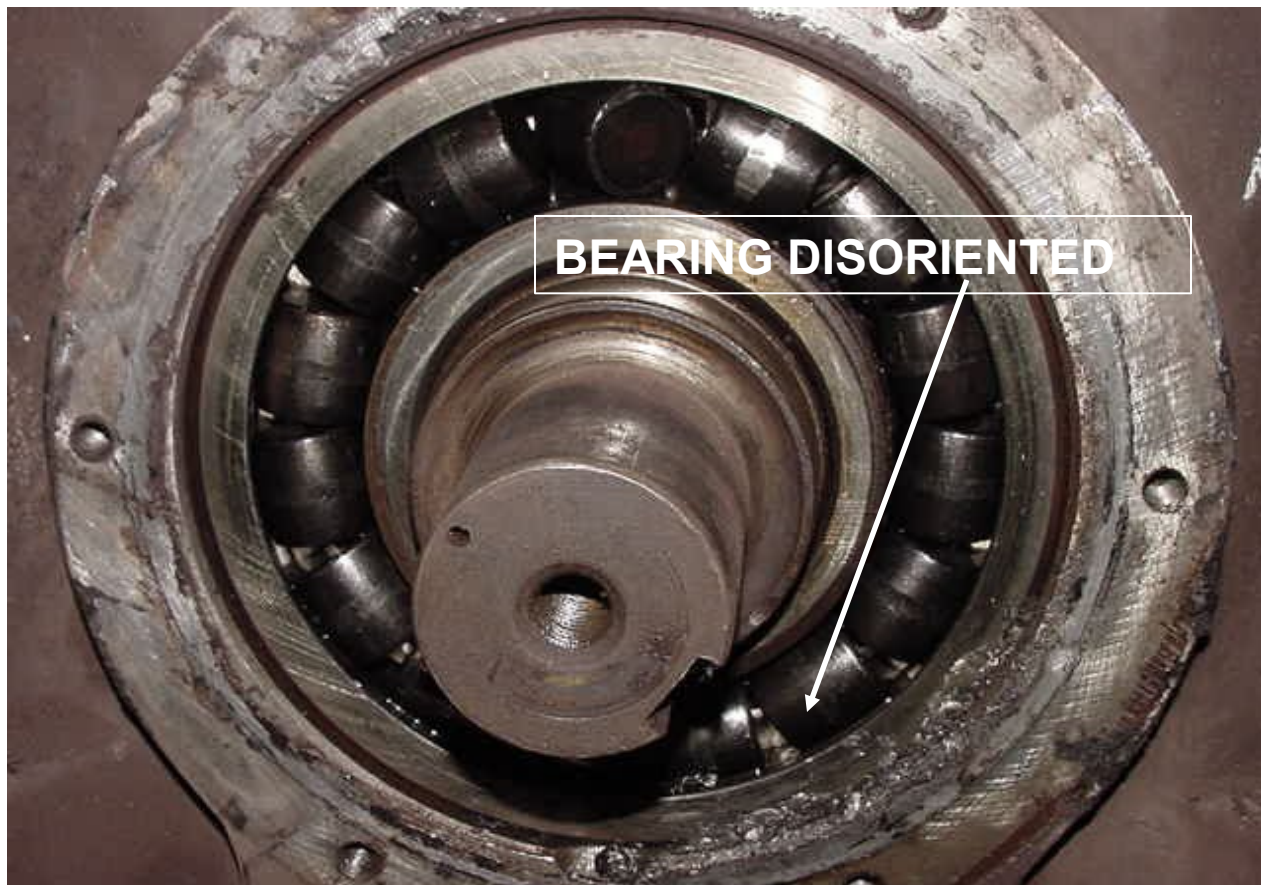
OBSERVATION NO : 2

It has double row spherical roller bearing .The cage had got completely damaged and the rollers had got disoriented.

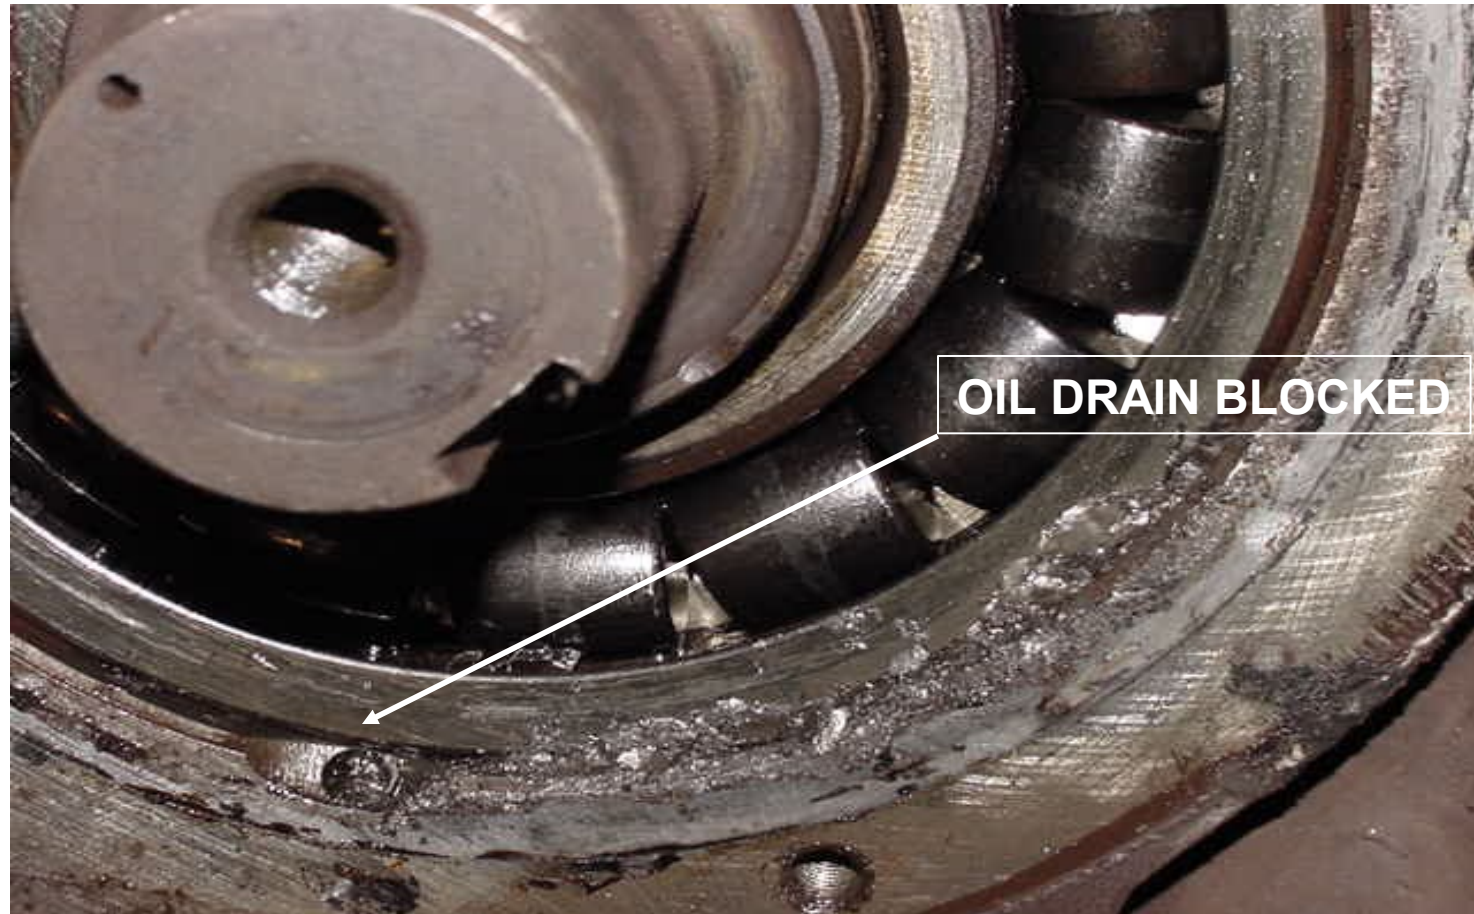
OBSERVATION NO : 3

The drain oil port on the damaged bearing side was choked

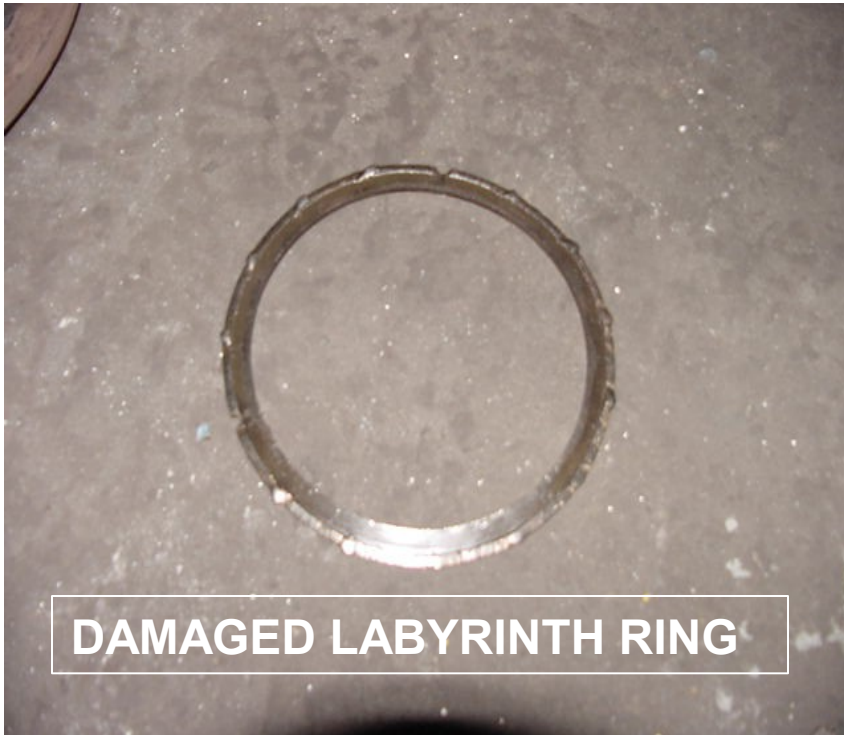
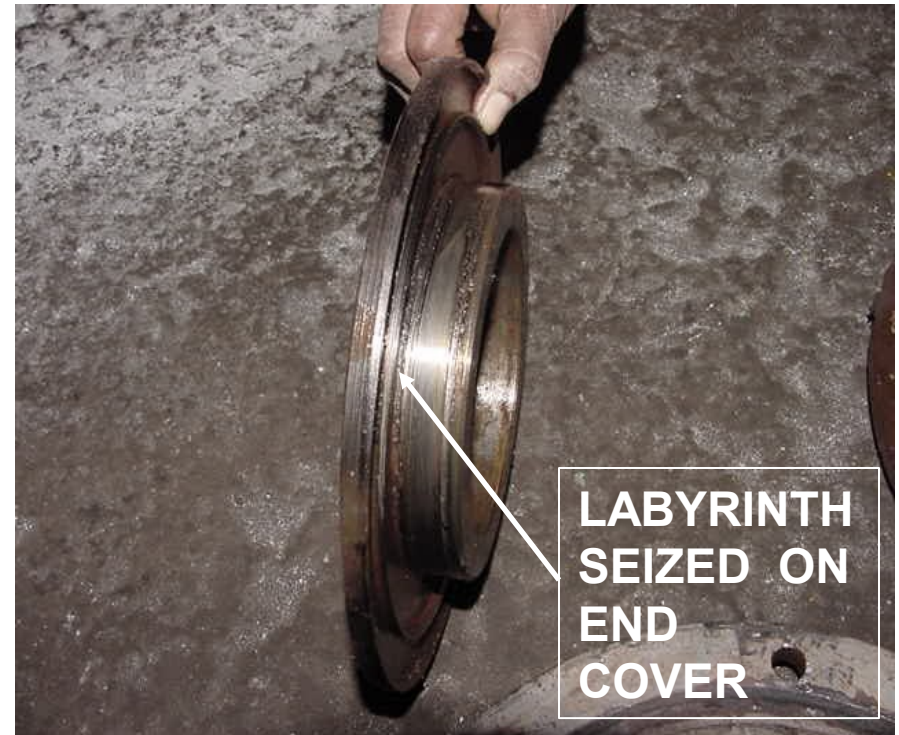
OBSERVATION NO : 4

The labyrinth ring was also badly damaged .
Labyrinth ring seized on end cover.

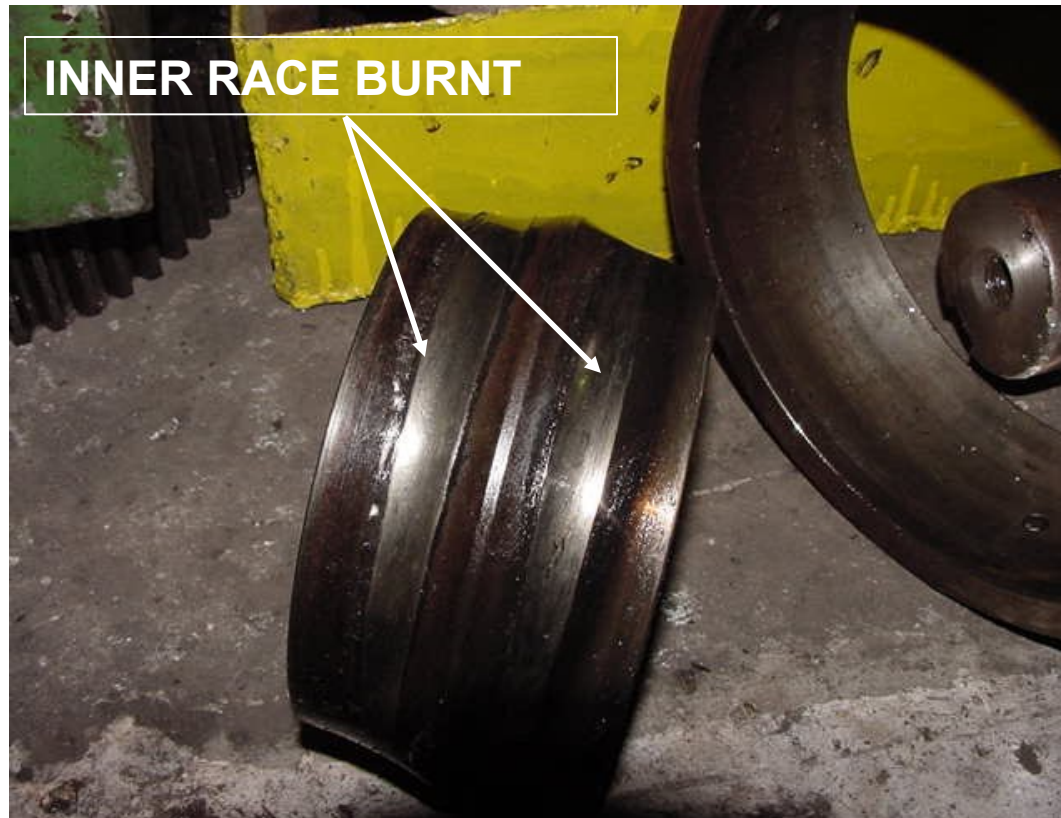
OBSERVATION NO : 5

The inner race of the damaged bearing showed signs of excess heat on the roller tracks
