IN HOUSE REJECTION: KAIZEN

3a.4 Can not Assemble

Physical Phenomenon : **Spatter in hole**
 Due to : Man / Machine / **Method** / Material

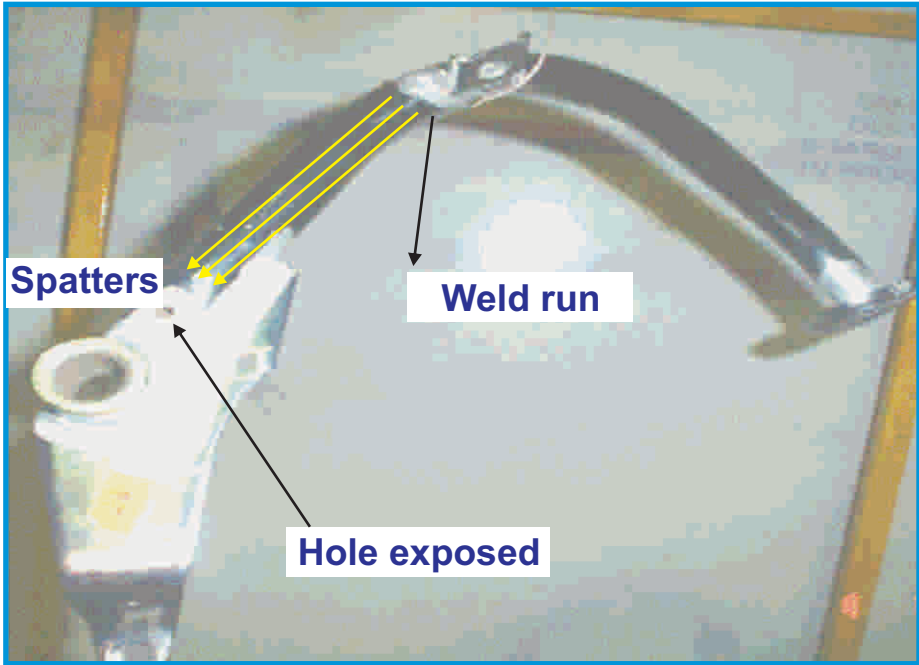
Before

Spatter enters inside hole

Root Cause : Hole Exposed
(Hole position below weld run).

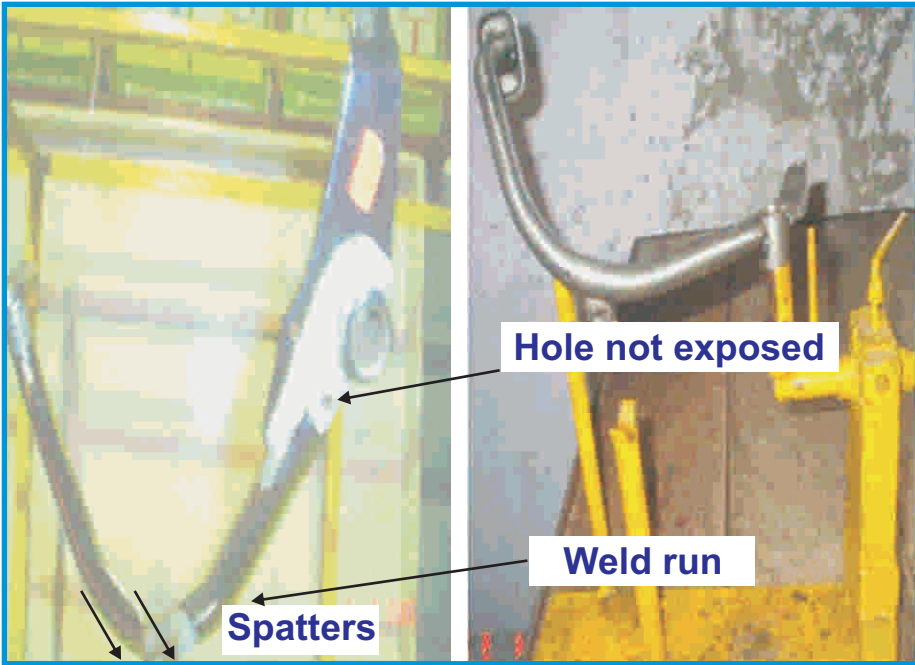
After

Kaizen Idea : Hole not exposed.

Kaizen : Part position changed for
hole position above weld run.
