IN HOUSE REJECTION: KAIZEN

3a.5 Can not Assemble

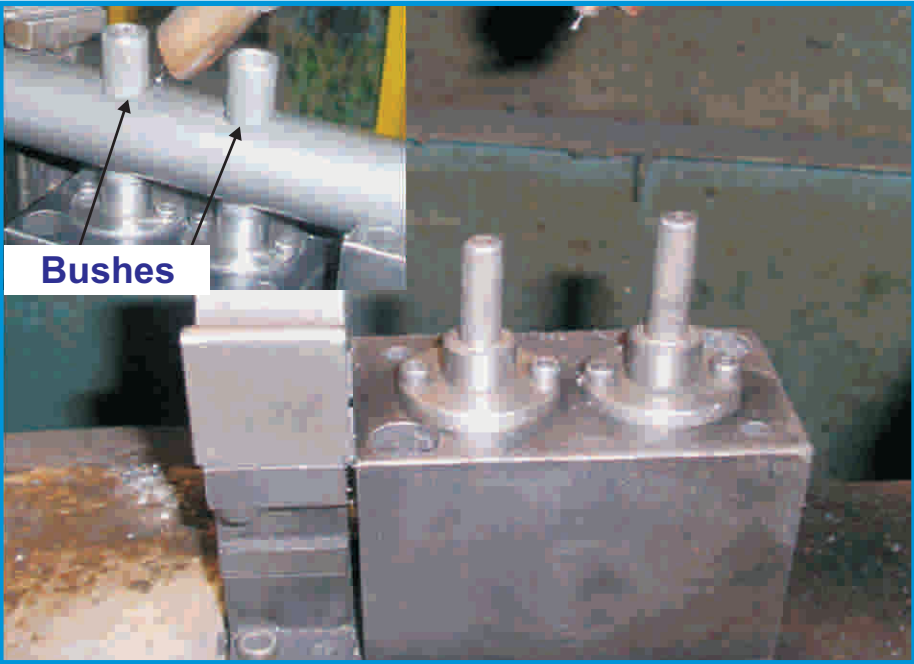
Before

Physical Phenomenon : **Spatters in tube**
Due to : Man / Machine / **Method** / Material

Spatters entry in bush.

Root Cause : No masking while bush welding.
