IN HOUSE REJECTION: KAIZEN

4b.4 STRENGTH

Physical Phenomenon : **Spot weak**
Due to : Man / **Machine** / Method / Material

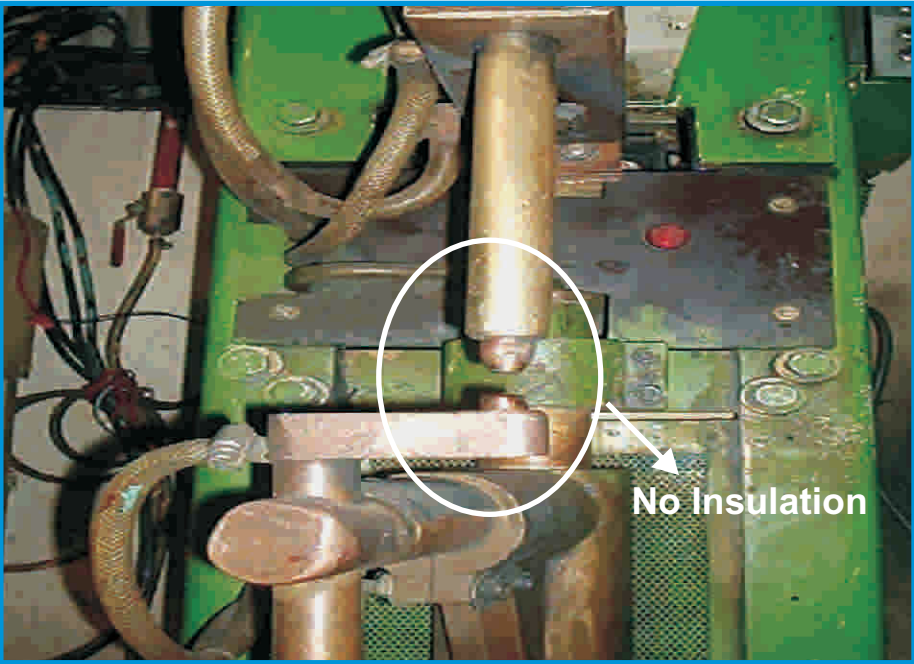
Before

Part touch to holder having no insulation.

Root Cause : Current by pass
