CUSTOMER COMPLAINT - CHANGE IN INSPECTION METHOD

1a.5 Cannot Assemble

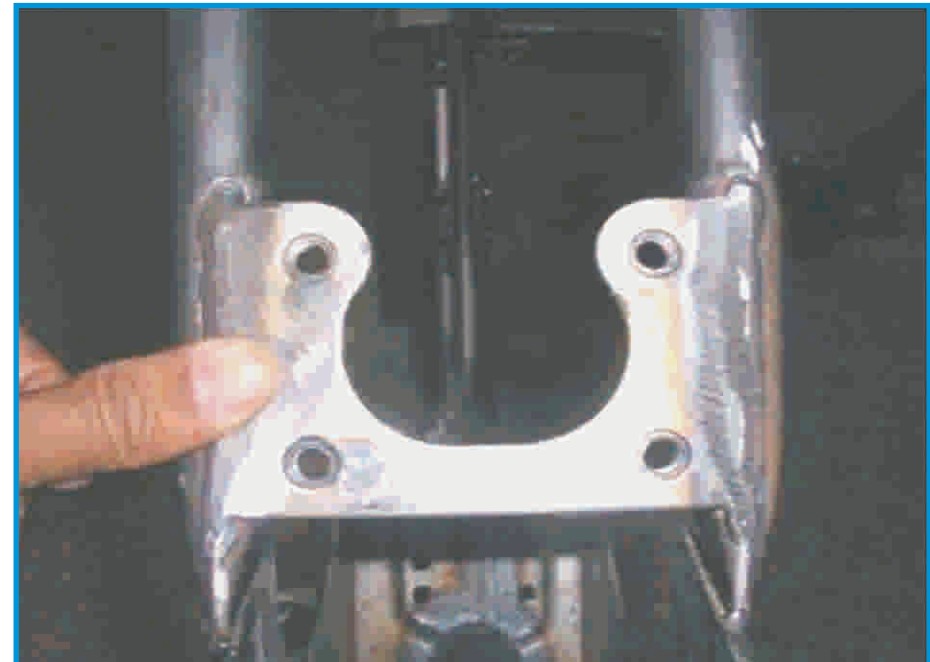
Physical Phenomenon : **Spatter on surface**

100% VISUAL
INSPECTION

100 % INSPECTION BY TOUCH & FEEL
