CUSTOMER COMPLAINT - CHANGE IN INSPECTION METHOD

1a.6 Cannot Assemble

Physical Phenomenon : **Wrong Part**

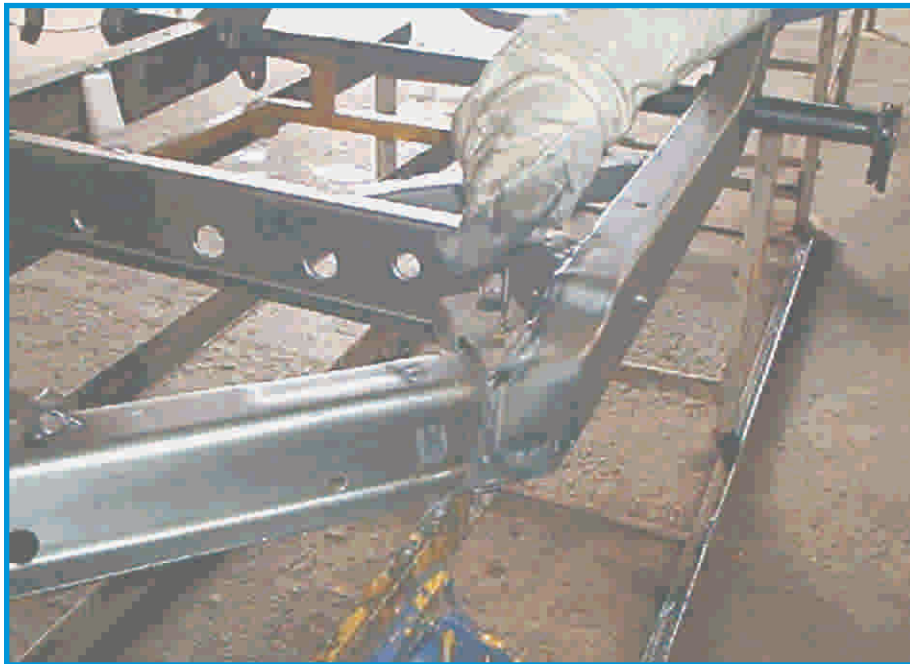
Before

M5 NUT WELDED IN PLACE OF M6 NUT
