# CUSTOMER COMPLAINT - CHANGE IN INSPECTION METHOD

1a.8 Cannot Assemble

Physical Phenomenon : **Part Missing**

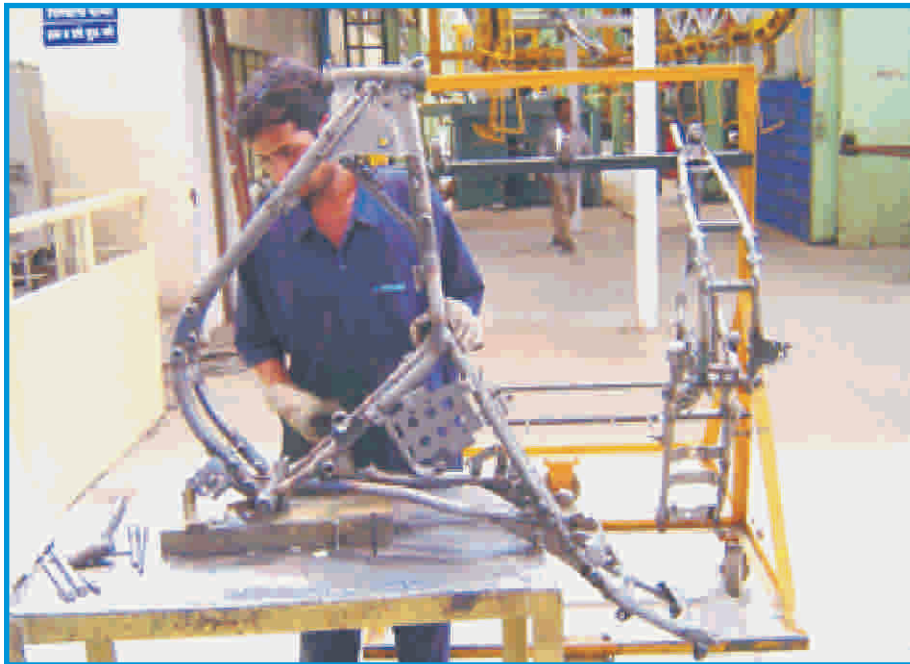
Before

100 % VISUAL INSPECTION & COUNTING
