CUSTOMER COMPLAINT - CHANGE IN INSPECTION METHOD

1a.10 Cannot Assemble

Physical Phenomenon : **Hole Missing**

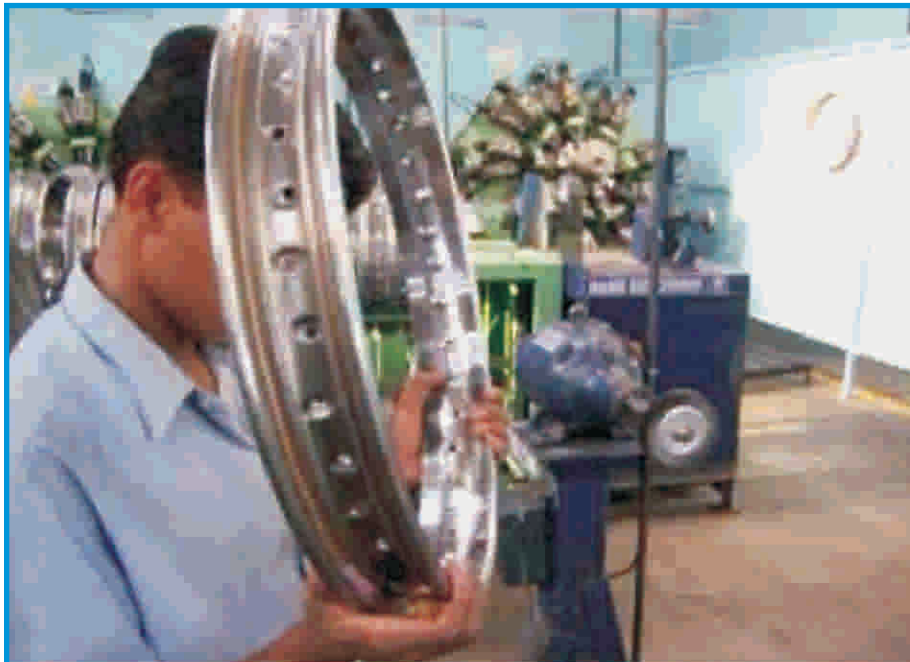
Before

100% BY VISUAL CHECKING
