CUSTOMER COMPLAINT - CHANGE IN INSPECTION METHOD

1a.11 Cannot Assemble

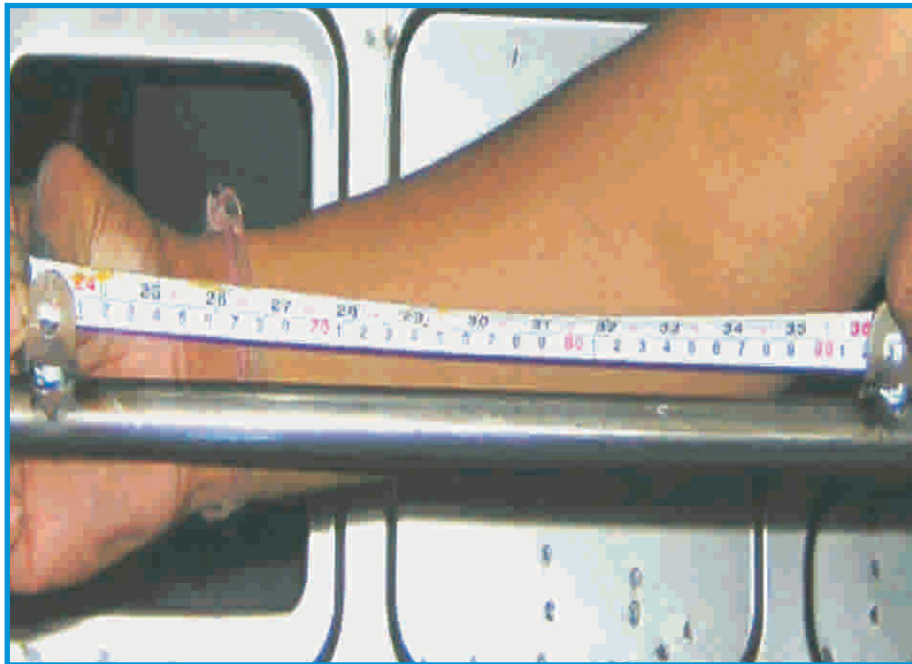
Before

Physical Phenomenon : **Wrong Position due Shift**

SAMPLE INSPECTION WITH
MEASURING TAPE
