CUSTOMER COMPLAINT - CHANGE IN INSPECTION METHOD

1a.13 Cannot Assemble

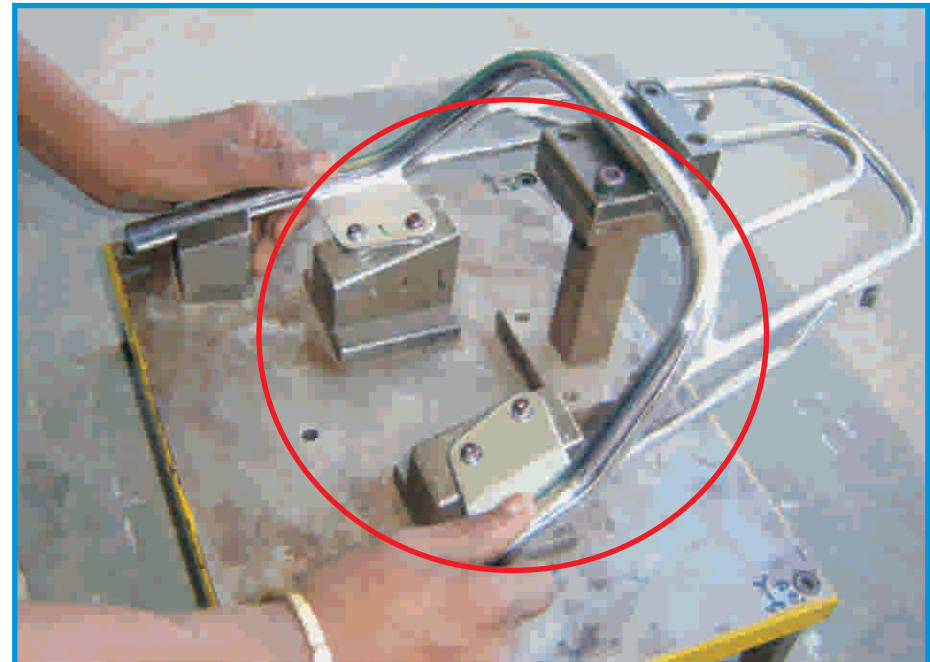
Physical Phenomenon : **Wrong Mounting Position due to Twist**

SAMPLING INSPECTION

BY RELATION GAUGE

100 % INSPECTION BY RELATION GAUGE
