6.6 KV VACUUM CONTACTOR PROBLEM 'G' BLAST FURNACE

BACKGROUND: It was observed on 8/12/2005 HT pump motor was not getting off from field panel.

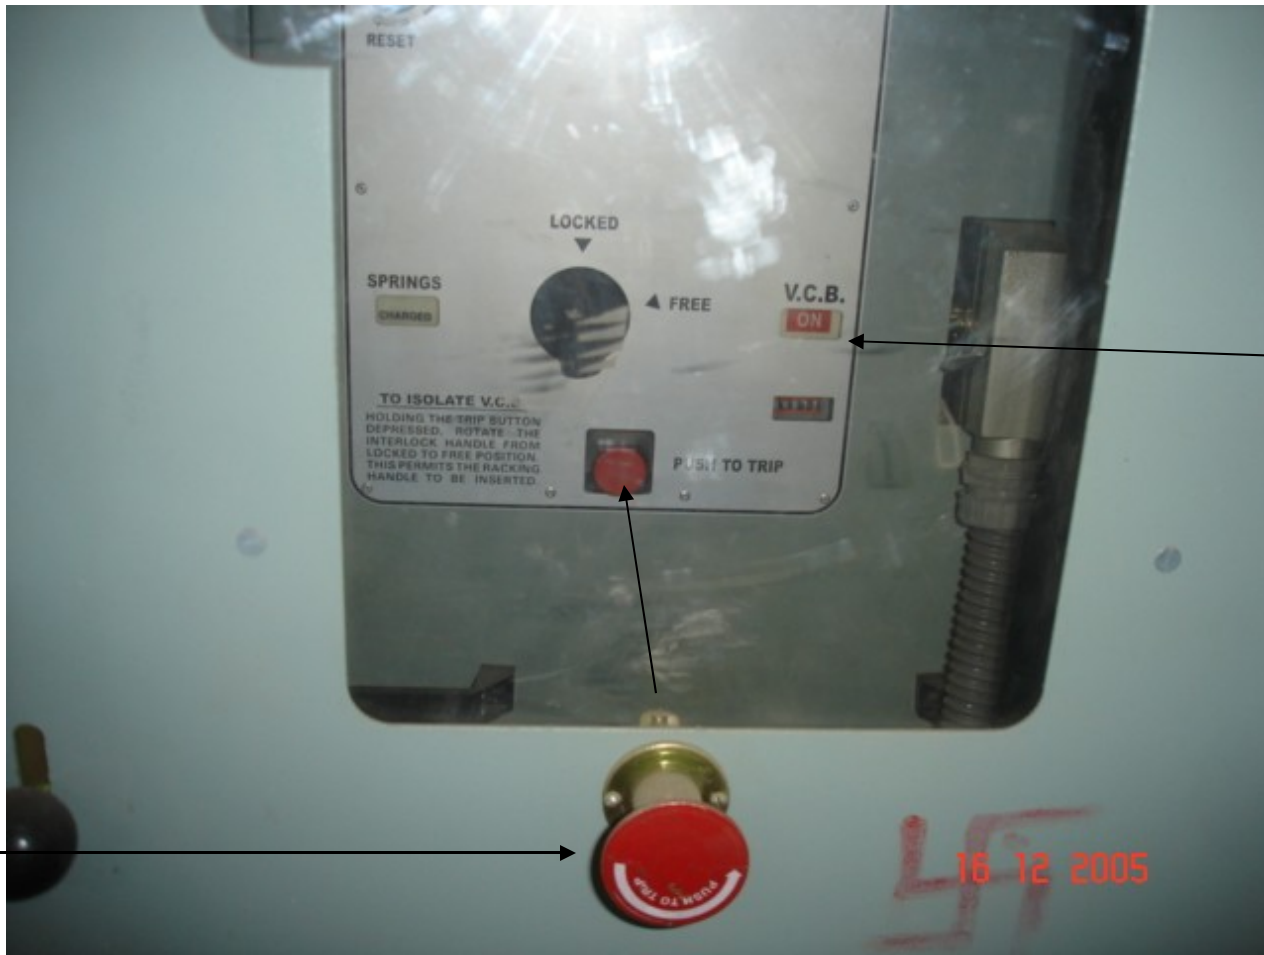
External mechanical trip at VCB

Breaker

External
lever
actuated
mechanical
trip s/w

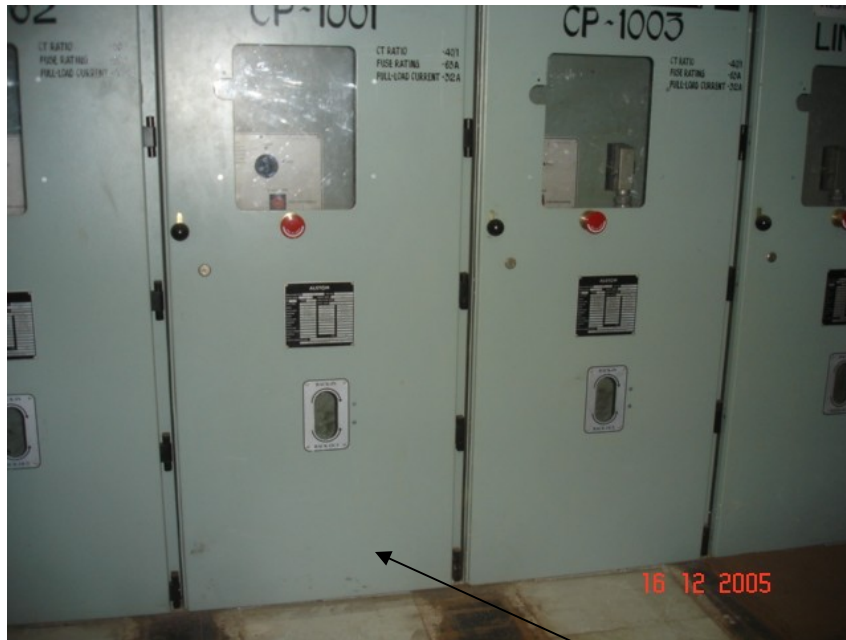
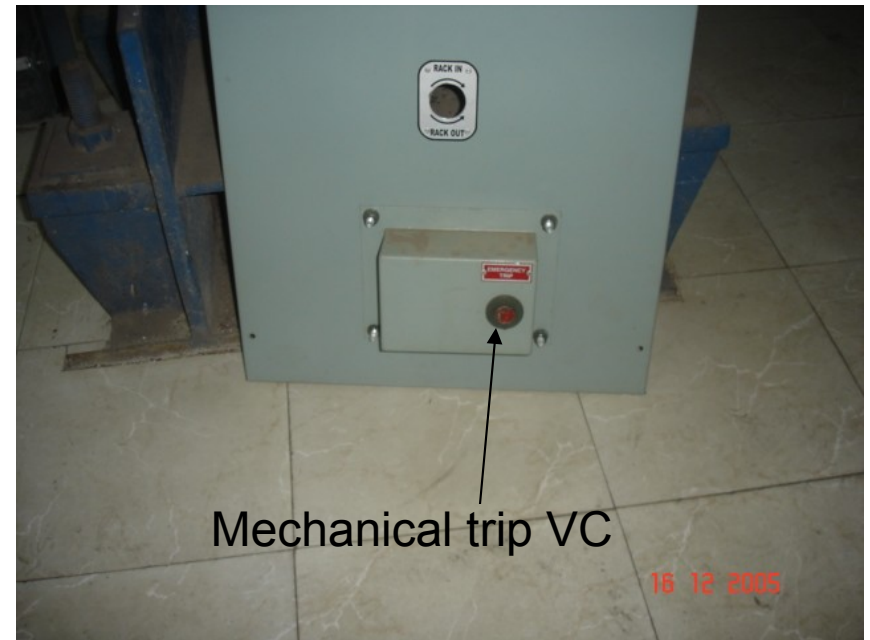
Vacuum Contactor

No External Provision to
operate mechanical trip

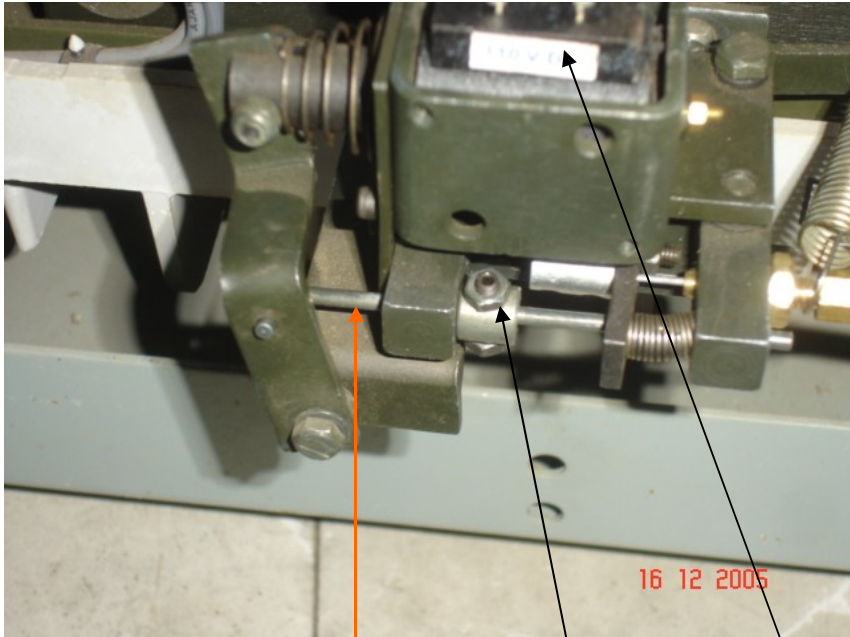
Round rod and grub screw

TATA steel pointed out that loosening of striker metal ring from its position was the main reason for not tripping the contactor and burning of trip coil. It was observed that the guide rod on which this metal ring is mounted is too thin (Approx. 3mm) and round, hence the striker ring got loosened due to vibration after several operation.

AREVA agreed to make necessary modification with permanent locking mechanism so that it does not loose after repeated operation.

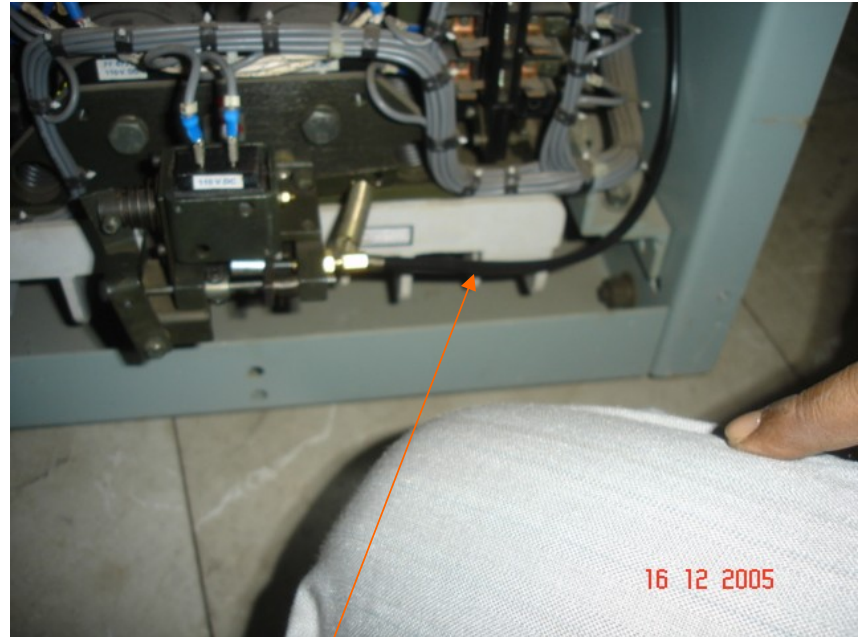
AREVA solution for mech trip

Coil 110 V DC

AREVA Engineers made site demo in front of G-furnace and ETG Engineers for the mechanical trip operation of HV contactor panel by Clutch wire mechanism connected between existing trip coil operating mechanism and the existing push button at the middle of the panel.

TATA steel didn't accept the arrangement since it was observed that slight loosening of clutch wire was not allowing the contactor to close, that means chattering of contactor taking place during switching on operation. It was proposed to provide oval cutout at the bottom with flap similar to the breaker-racking opening and loose operating handle (insulated) so that mechanical trip is possible from outside the breaker through the opening whenever required.

AREVA tested the existing trip coil and confirmed that it can withstand maximum 27second. They also brought one new trip coil with more number of turns hence more resistance that will withstand about 90sec of continuous energisation. Since the trip coil is getting disconnected from supply as soon as contactor trips it is felt that new trip coil will be more suitable. AREVA shall replace all trip coils with new higher rated trip coil and submit the test report of new trip coil.

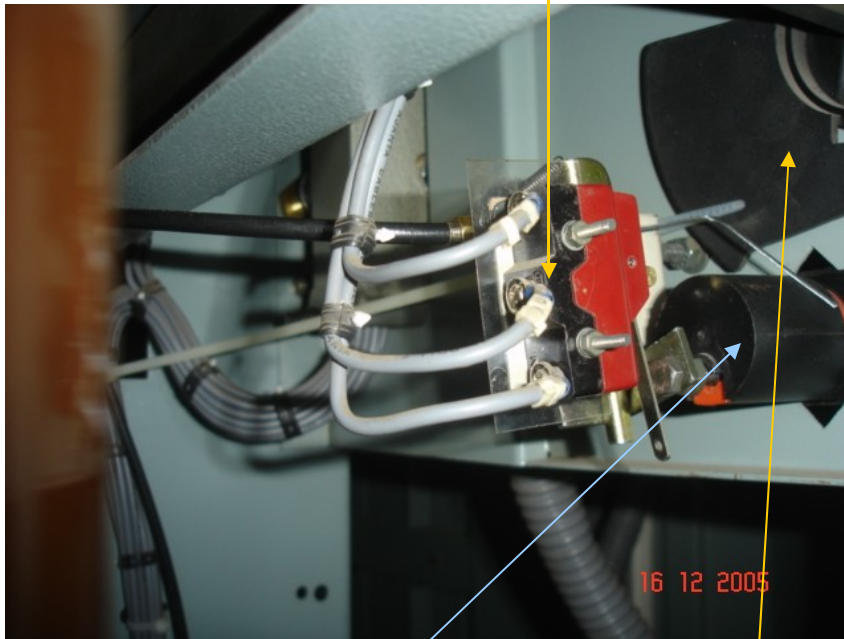
Electrical s/w available instead of mechanical trip mechanism.

Trip actuator

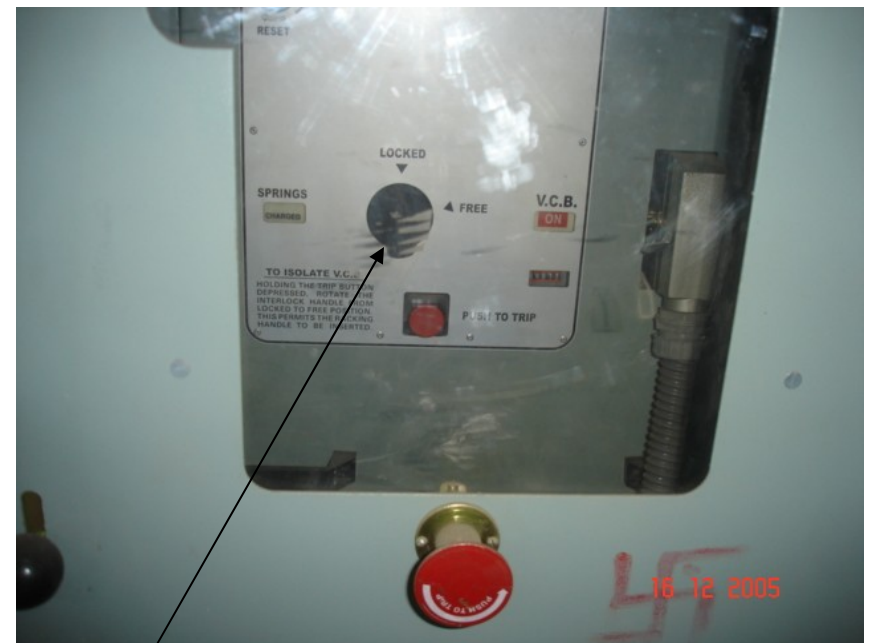
Lock/Free s/w for VC in/out should trip VC mechanically (Standard safety Features)
