FAILURE OF BLEEDER VALVE

28.12.2005

G Blast Furnace

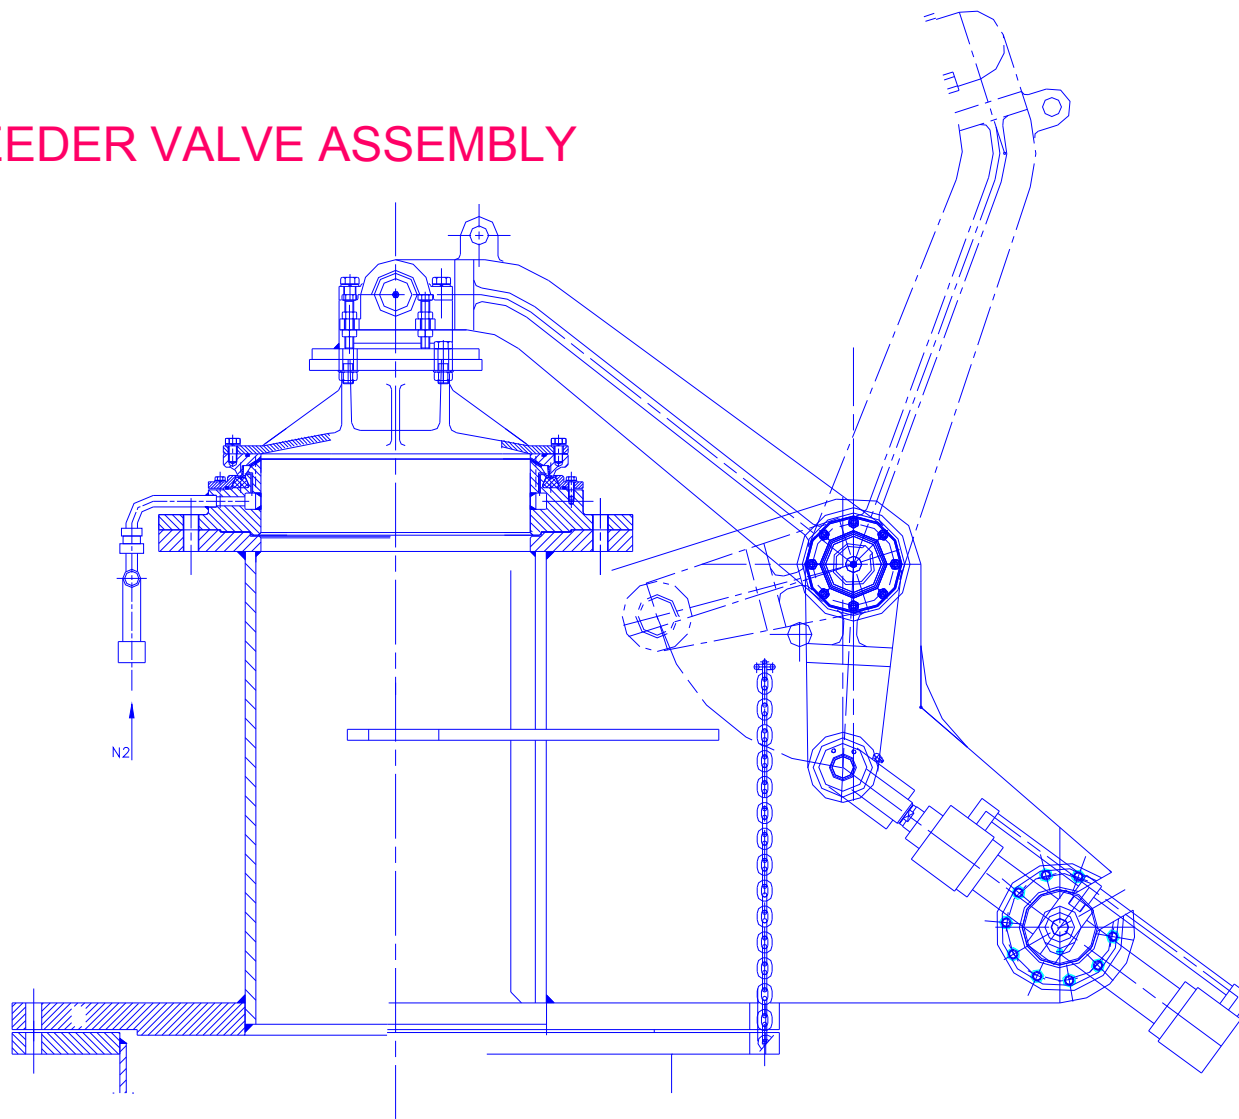
BLEEDER VALVE ASSEMBLY

Whenever there is bleeder opening due high furnace pressure (which may be due to burden slipping or due to high gas network pressure), crude gas released at high velocity, carrying small coke particle, depending on the magnitude of burden slip. If at the same time crude gas temperature is more than 450 deg C, gas will self ignite as soon as it will come in contact with air. At the same time after bleeder opening, when furnace pressure gets normal, bleeder will received the close command and subsequently it was observed that there is gas leakage from bleeder valve.

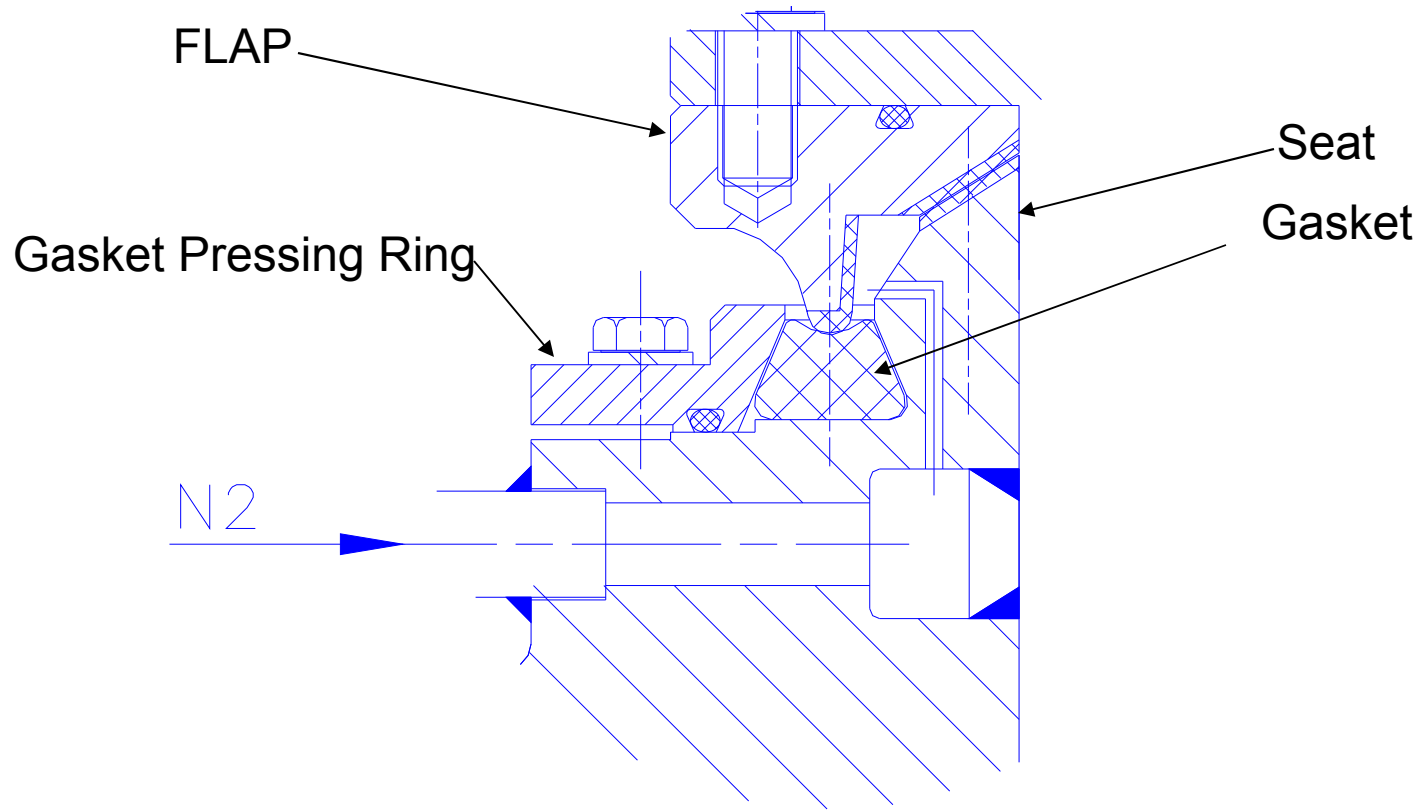
BLEEDER VALVE ASSEMBLY

On 28th May, it was observed that the coke particles got pressed in sealing gasket, which was not sweep away by the flushing N₂, because the height of gasket pressing ring was 5mm more than the sealing gasket height. The higher elevation of gasket pressing ring was preventing coke particle to sweep away. Also it was observed that the available N₂ flushing arrangement was not covering the entire area of sealing gasket.

On 18/06/05, the suggested method of external N2 flushing was implemented in bleeder#1 & #2. The performance of modified gasket pressing ring was also checked on 18/06/05 and no coke particle was found in bleeder#2.
