Failure of Vessel #2 non drive end
Bearing at LD#2

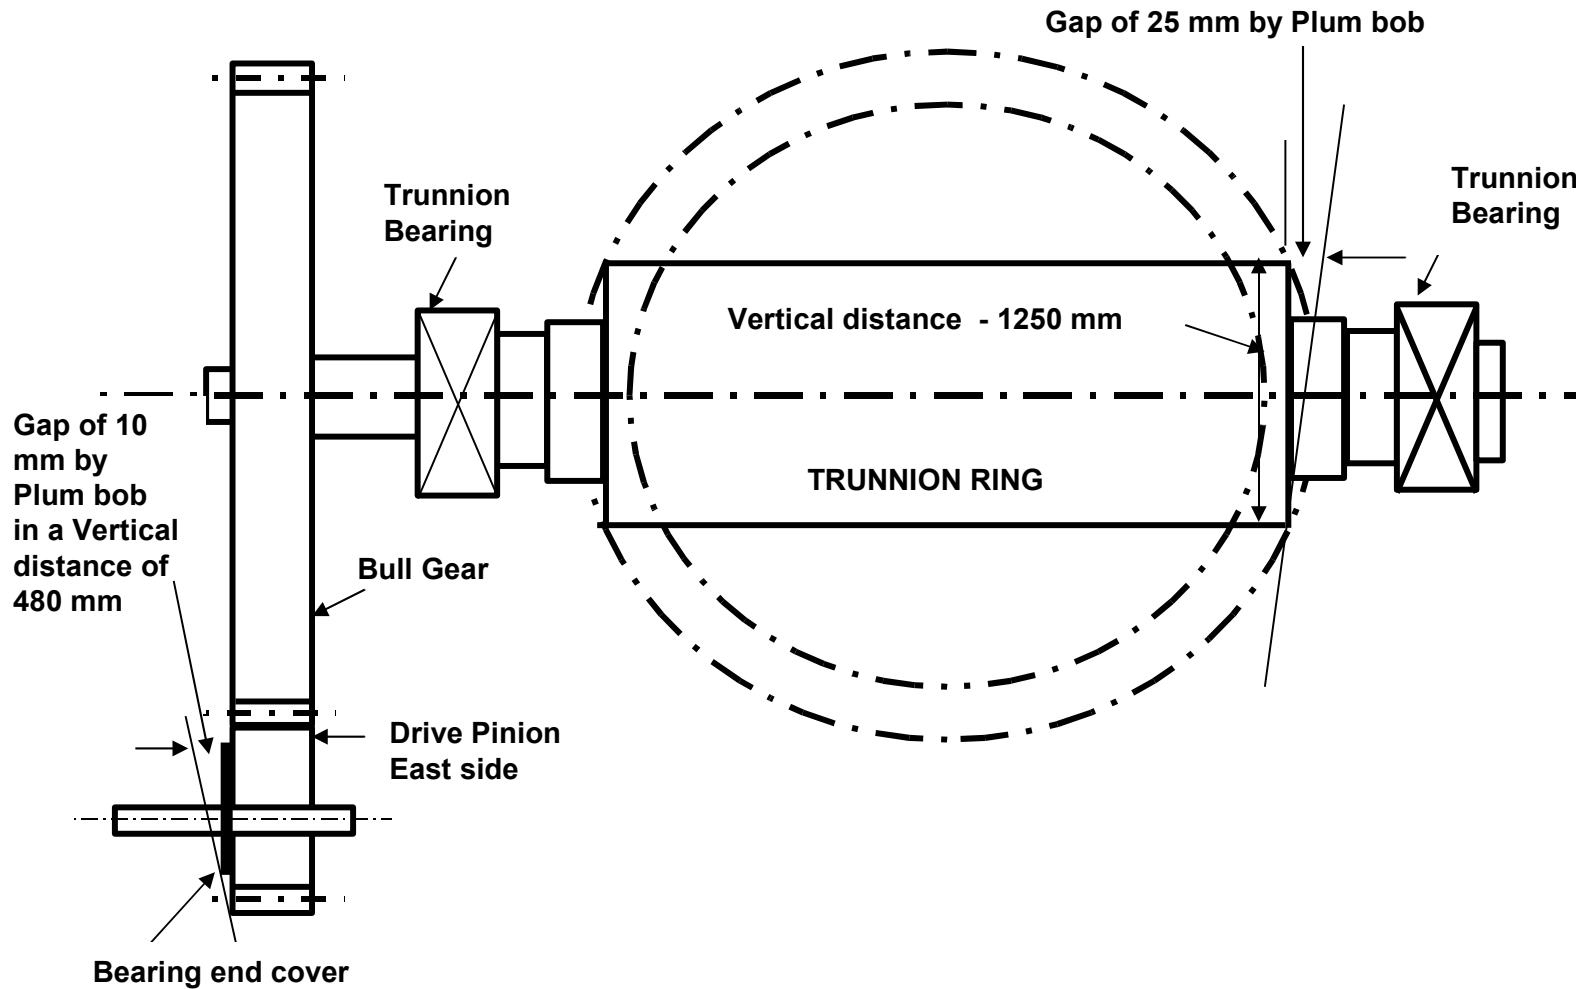
VESSEL WITH DRIVE ARRANGEMENT

- ON 1ST OCTOBER 2005, B SHIFT, INTERMITTENT CREAKING METALLIC SOUND NOTICED IN NON DRIVE END (NDE)TRUNNION BEARING
- GREASING DONE. THE VESSEL GIVEN IN SERVICE AND KEPT UNDER CONSTANT WATCH
- ON 2ND OCTOBER 2005, AT AROUND 1:00 AM, THE ABNORMAL SOUND INCREASED SIGNIFICANTLY AND THE NON DRIVE SIDE TRUNNION PIN LOWERED DOWN BY APPROXIMATELY 28 MM INDICATING BEARING BREAKAGE.
