**STOPPING OF MAERZ KILN  
# 2 DURING REVERSAL  
AT RPD**

December 28, 2005

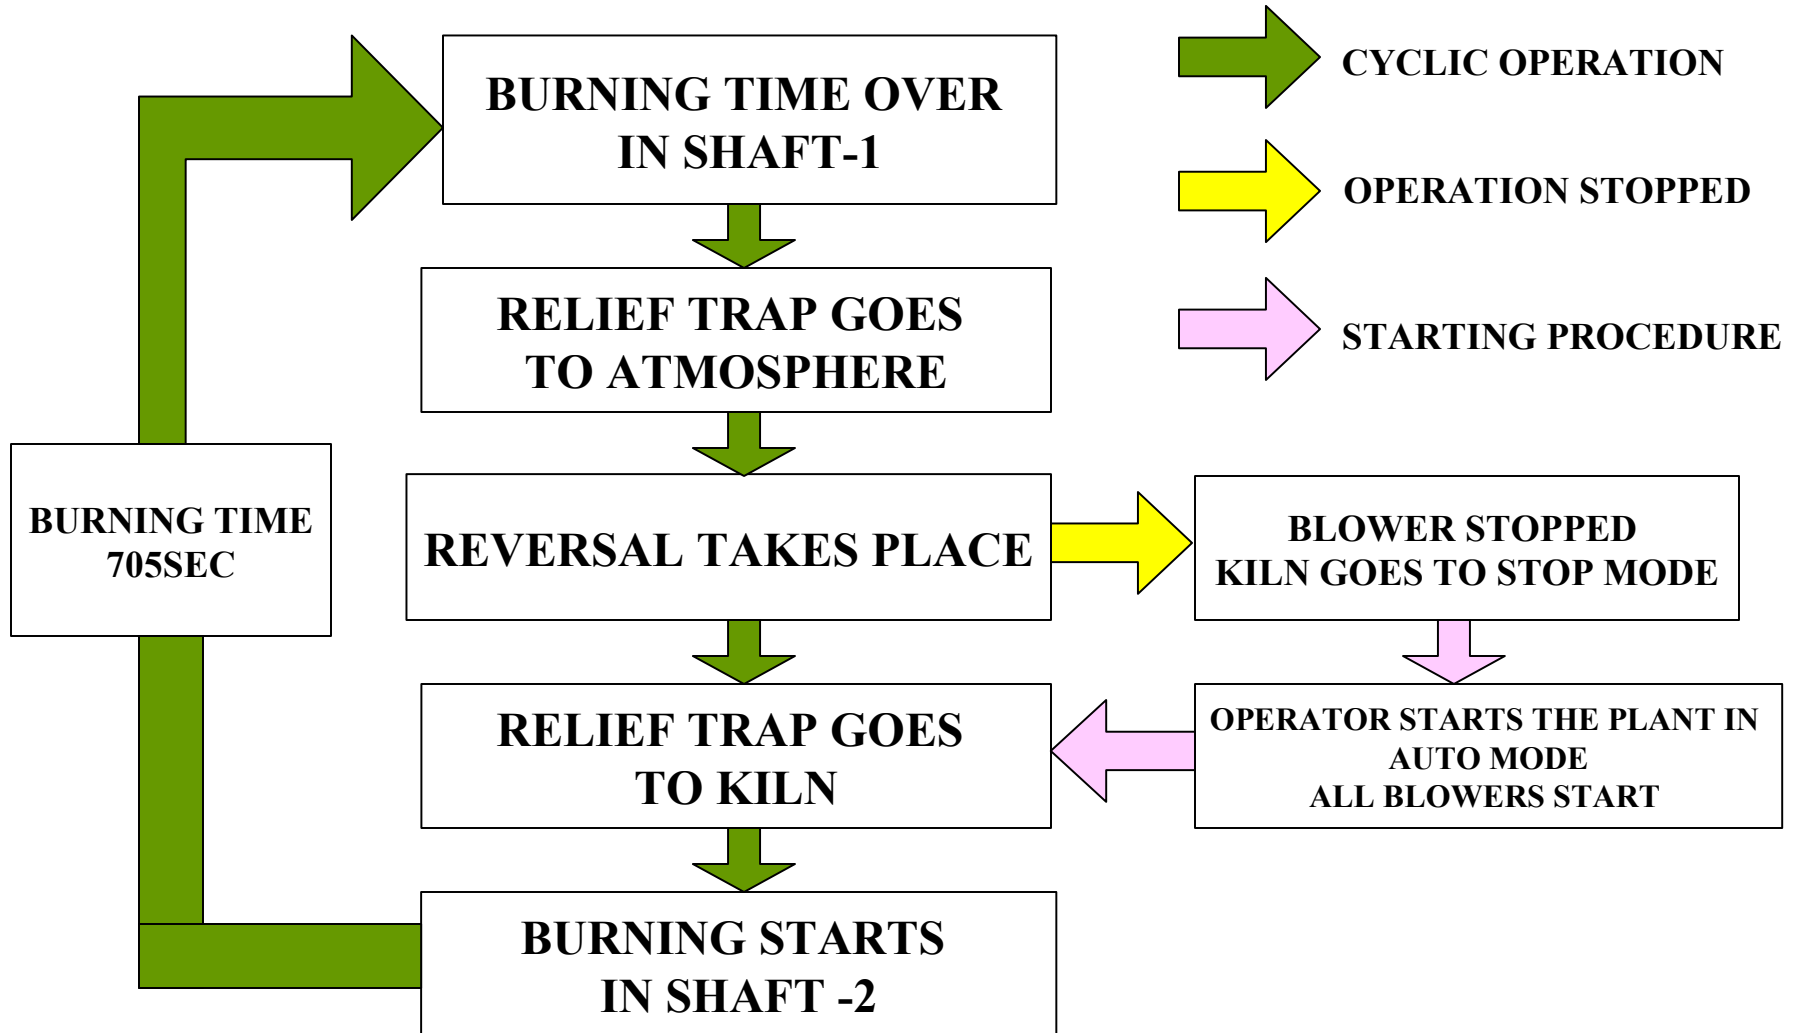
# REVERSAL SEQUENCE OF MAERZ KILN

# REVERSAL PROCESS

**RELIEF TRAP GOES TOWARDS  
ATMOSPHERE**

**KILN GETS DEPRESSURISED**

**DISCHARGE TRAP OPENS FOR 6 SEC**

**SHAFT CLOSING TRAP & SERVICE HOPPER  
TRAP OPENS FOR MATL CHARGING  
AND CLOSES AFTER 10 SEC**

**RELIEF TRAP GOES TO KILN**
